## Sustainable Piggery Effluent Utilisation in Australian Farming Systems

Case studies on the development and implementation  
of Nutrient Management Plans at ten Australian piggeries

**PROJECT TITLE:** Caring for our Country - Nutrient Management Plan Development

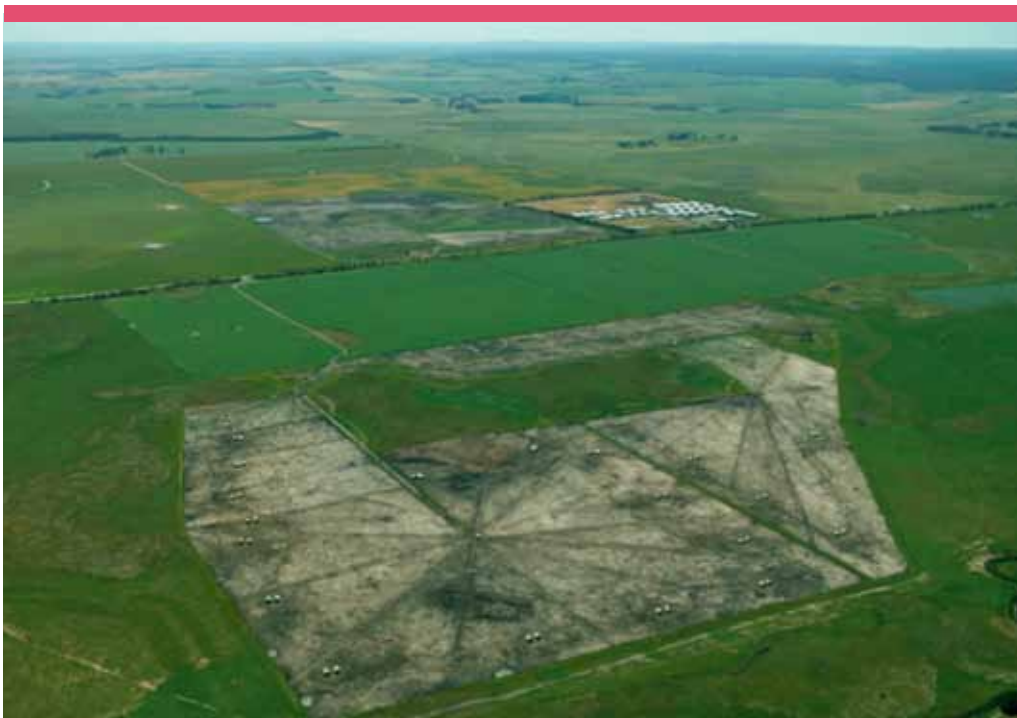
Photo: Aerial view of the site showing crop growing on land that has had pigs on it for three years

The property is managed using a 12 year rotation involving three years of pig use, followed by nine years of alternative use; a rotation of wheat or barley, canola and livestock grazing of pasture or cereal stubble. Following the three year pig phase, the paddocks are remediated by levelling, refilling the wallows and ploughing twice before direct drilling with broad leaved crops.

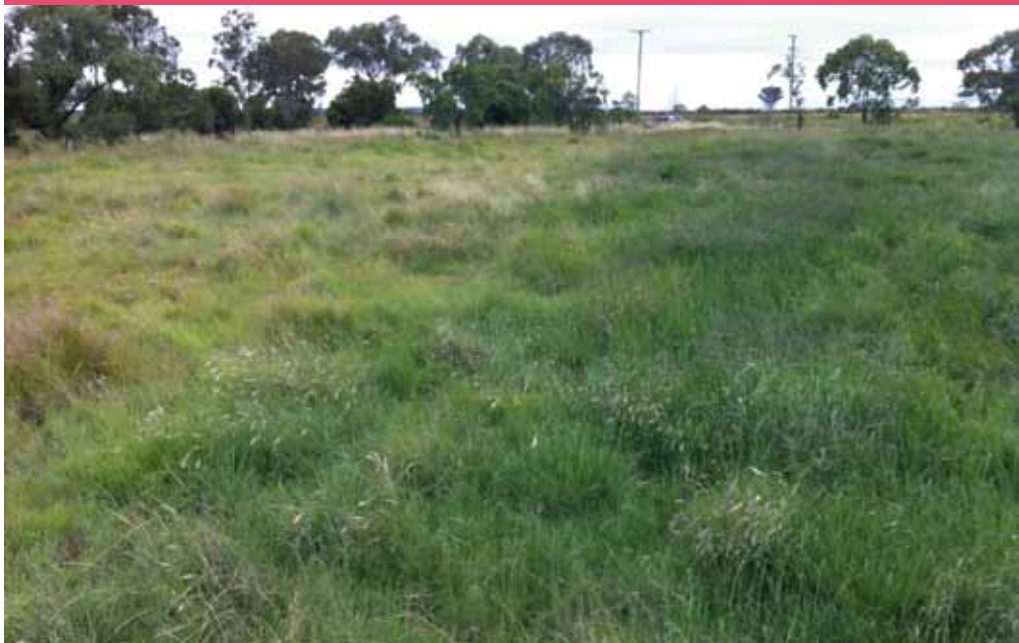
Photo: Contrast in perennial pasture under irrigation versus unirrigated

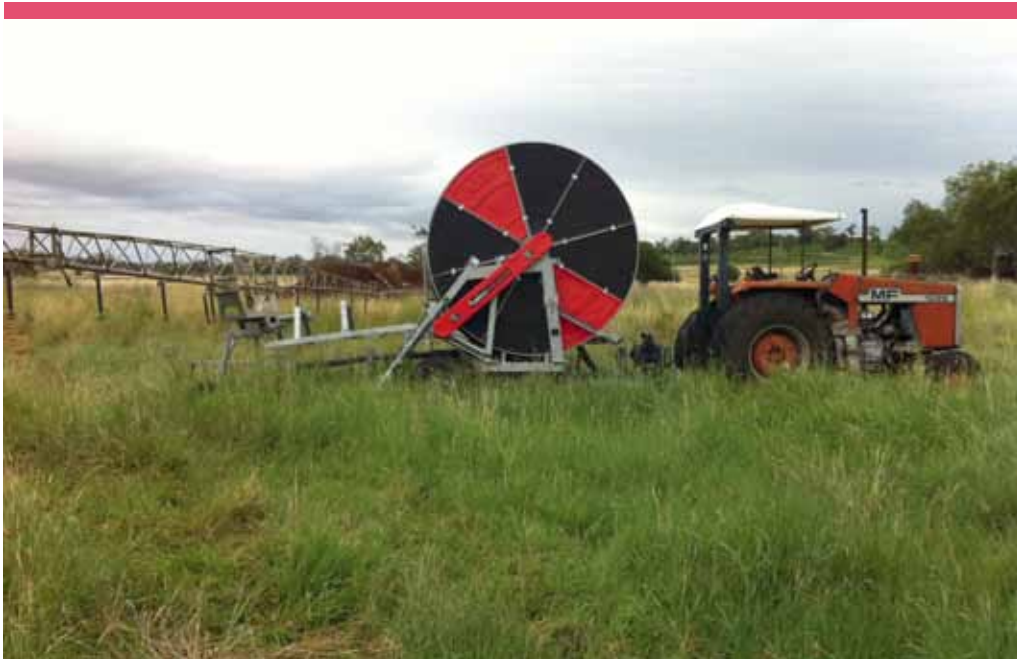
Photo: The new irrigator can spread effluent over large areas

The activities undertaken as a result of the Nutrient Management Plan (NMP) have been to purchase and install an irrigator which can spread effluent across the 40 hectare area to be used for improved pasture hay production and cattle grazing. This has reduced the likelihood of the ponds overtopping if usage in the compost operation is further reduced.

“Since installing the irrigator, we have been able to distribute the nutrients over a much larger amount of land than could be done previously. The dual reel system gives us absolute flexibility to irrigate the correct amount of nutrient on the areas as required.”

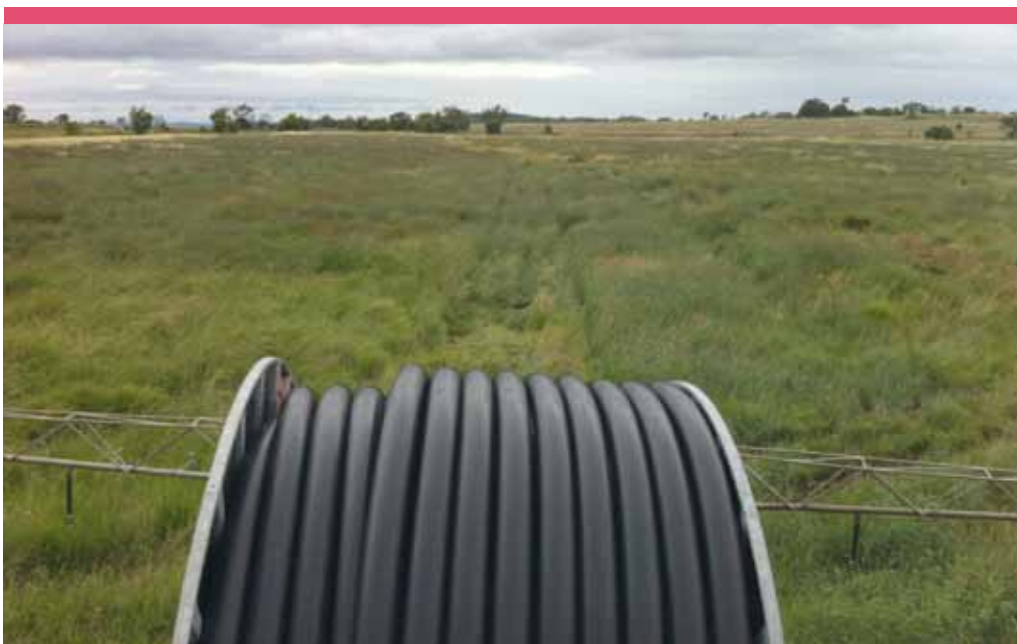
Photo: Flexible irrigation options are key to the system's success

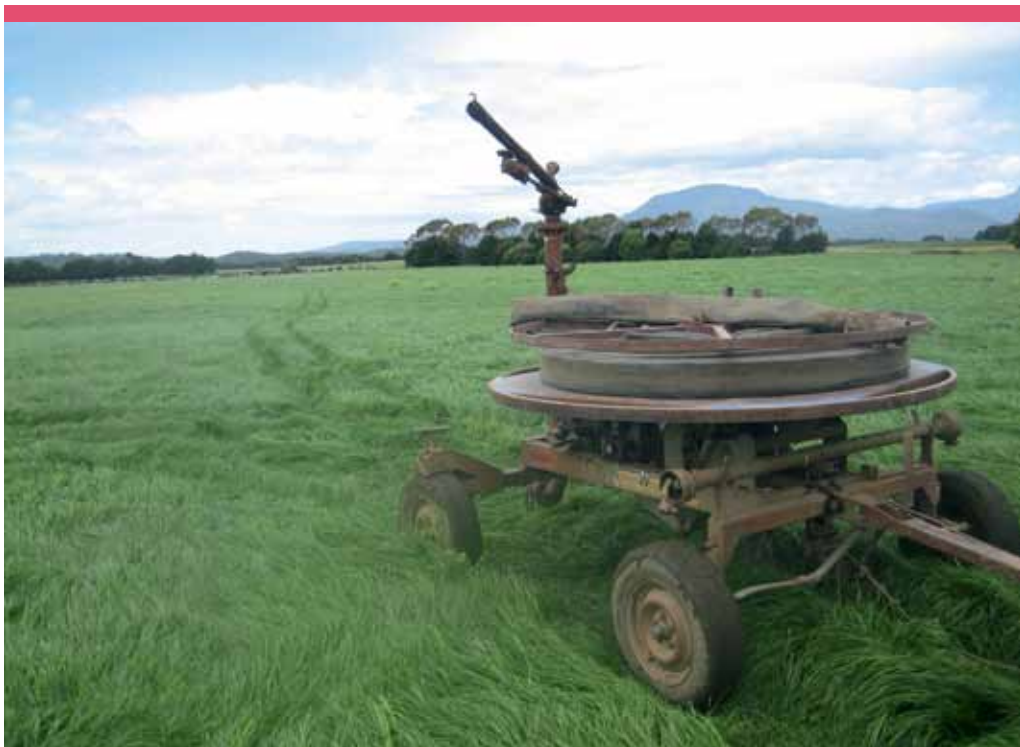
Photo: A travelling irrigator is now used to spread effluent

Effluent management reuse and costs could be improved by installing an agitator, pump, pipe work and travelling irrigator to spread the liquid effluent rather than using a vacuum tanker. The monitoring plan would include regular effluent and soil testing in all reuse and pig site areas.

In order to meet these recommendations a new effluent irrigation system has been installed on the property. This includes the installation of a new suction line to the largest of the effluent holding pits and extensive underground pipe work for connection to a travelling irrigator for spreading over a larger area. The sprinkler will travel approximately 200 metres at each cycle and be able to cover two hectares each month, taking into account seasonal and weather conditions.

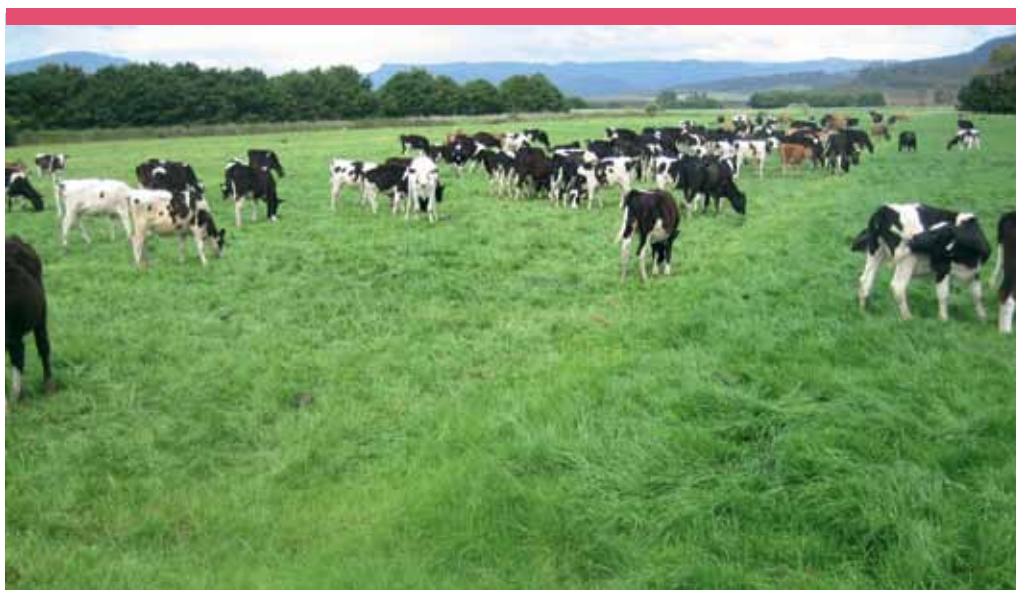
Photo: Pasture under irrigation

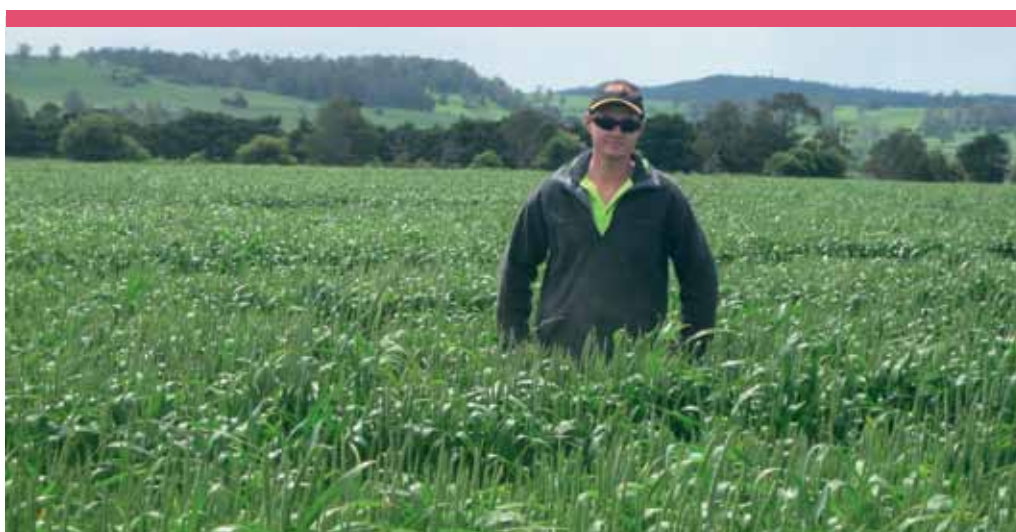
Photo: Crops are benefitting from the new irrigation system

The implementation of the improved irrigation and cropping program is expected to be shown as an example of best practice for the wider farming community in the area, as well as yielding an immediate return through reducing running costs and increased crop yields.

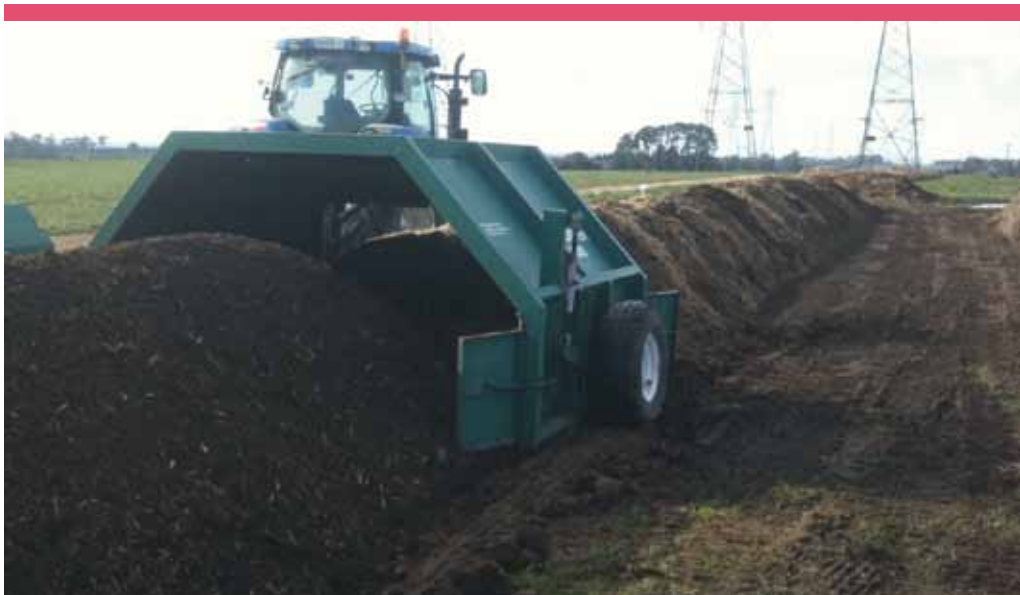
Photo: A windrow turner makes an expanded compost operation easier to manage

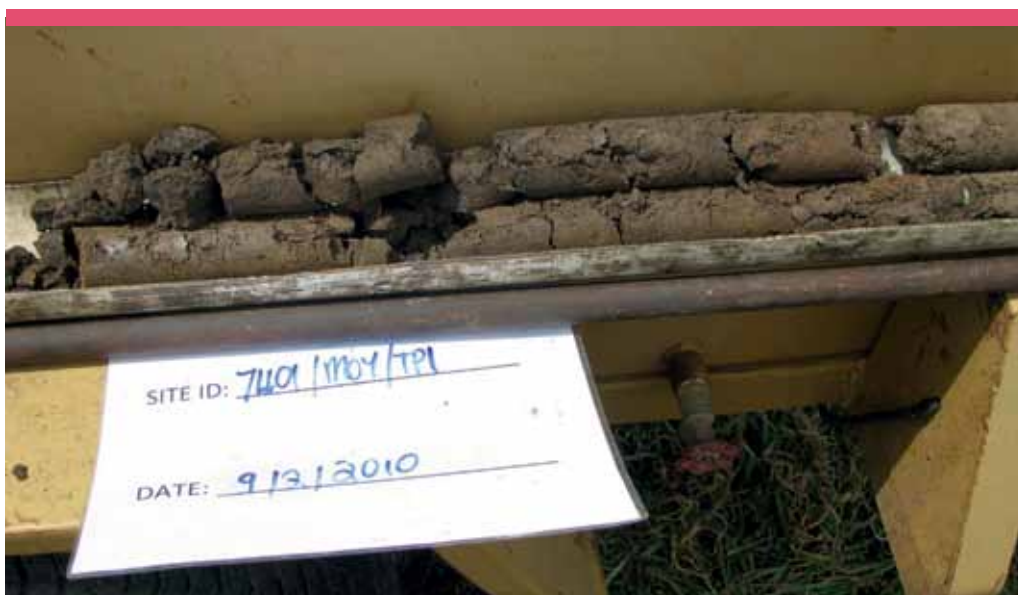
Photo: Initial soil samples show high levels of sodicity

Annual soil monitoring is undertaken after the end of a cropping cycle or at the end of the growing period for permanent pastures. The soil samples are taken at 0-10, 20-30 and 50-60 cm depths.

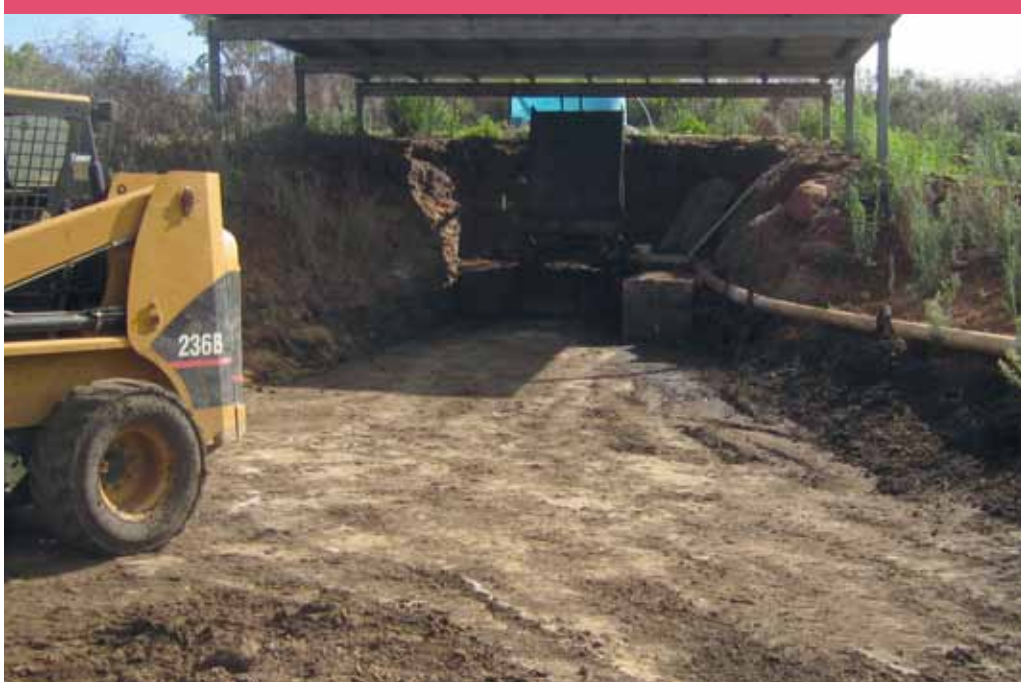
Photo: Screened piggery solids offer a valuable source of nutrients for cattle and hay production

A compacted and bunded pad is necessary for storing screened piggery solids prior to spreading and contour banks should be constructed in paddocks adjoining waterways to prevent nutrient run-off.

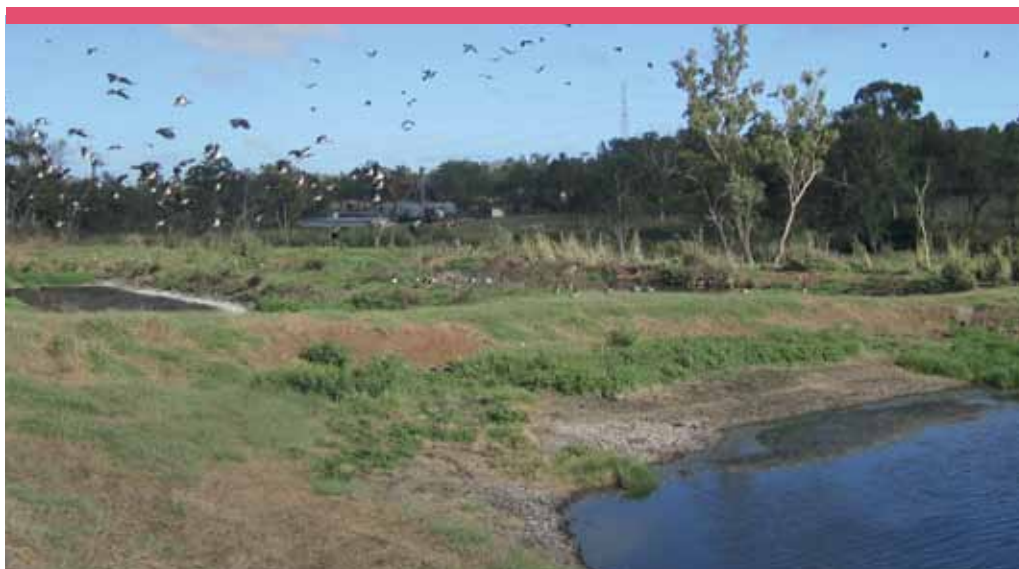
Photo: Ponds from which effluent is irrigated using the new centre pivots

Solids and effluent produced by both the pig and cattle facilities are spread on the property. The liquid effluent from the 10 ML holding pond is irrigated using two centre pivots onto several paddocks, and onto other paddocks using a hard hose travelling irrigation system.

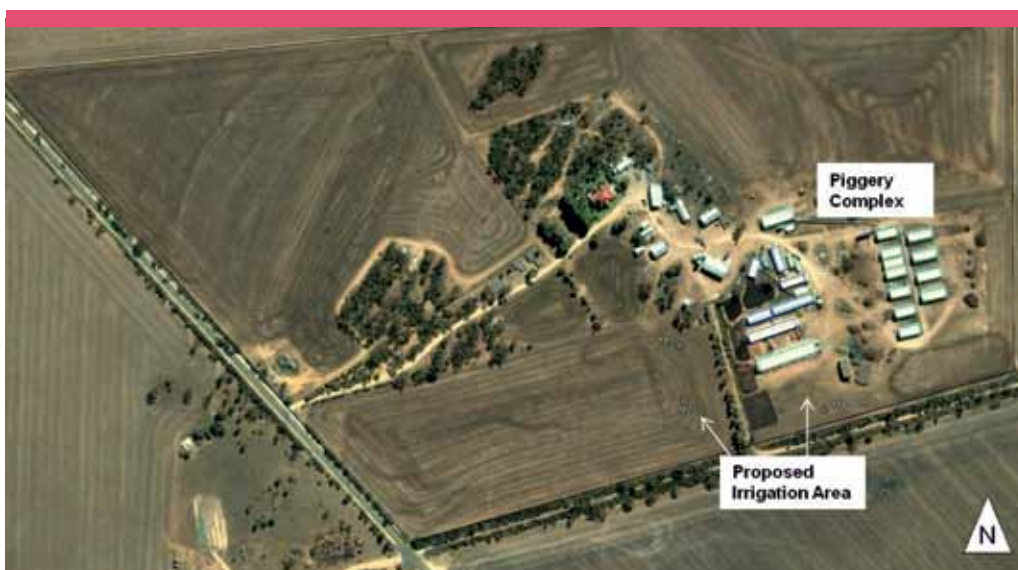
Photo: The NMP identified that the proposed irrigation area was not sustainable

The suggestion of irrigating a five hectare site with treated effluent would not be considered sustainable as the effluent is high in salts and the SAR level may contribute to salinity and sodicity in the reuse area; soil analysis indicates that the proposed site already has high nutrient levels and moderate salt and sodium levels in the subsoil; and, irrigating a 5 t/ha oaten hay crop would only require 0.1 ML/ha of effluent which at these low rates would not be financially feasible.
