Sludge Management for a Covered Anaerobic Pond at Bears Lagoon Piggery

Final Report
APL Project 2009/2295

June 2013

AgSystems Design
Scott Birchall
6 Holland St
Shepparton VIC 3630

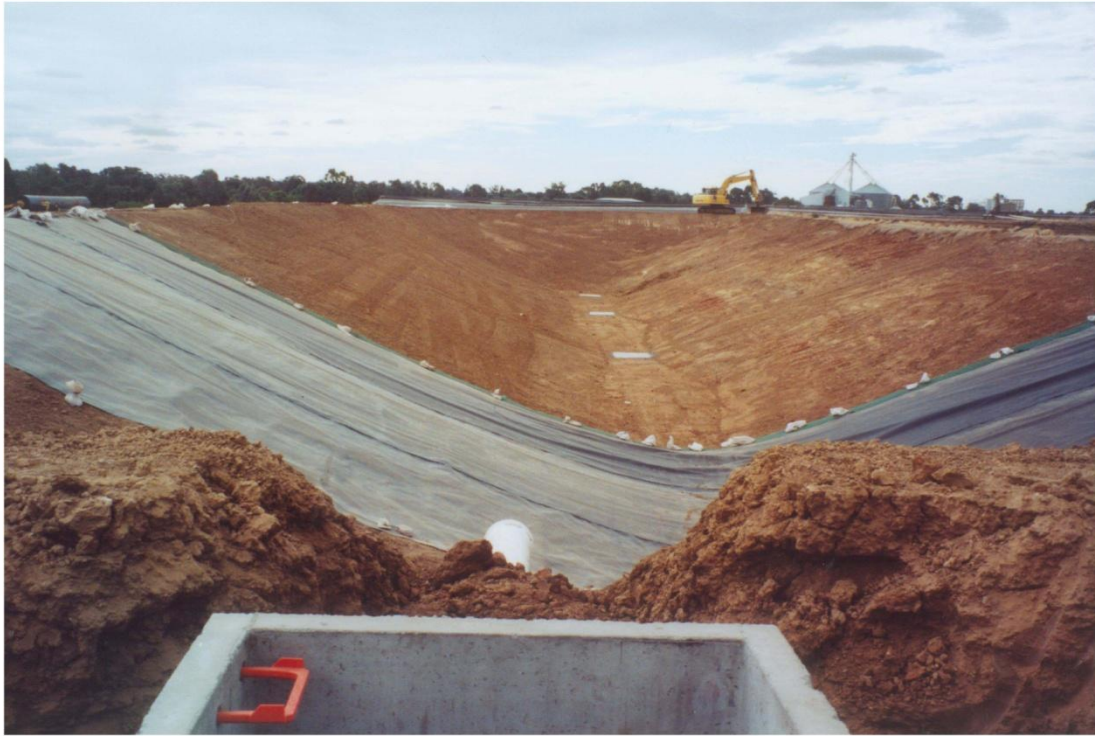
Figure 2: The completed earthworks with cover shown prior to floating (2004)

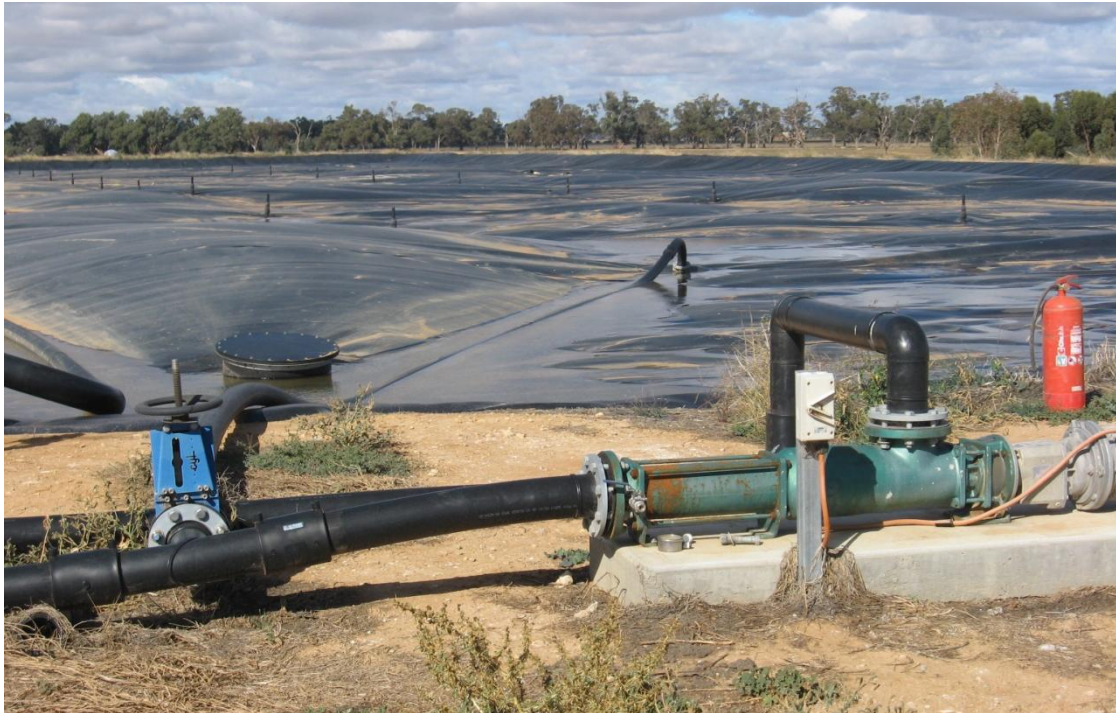
Figure 3: Original sludge extraction pump (previous location at inlet end)

The sludge extraction system that was in existence at the start of the project was designed to recover sludge from four separate points along the V-shaped base of the pond. The original pump was a positive displacement helical rotor operating at ~ 380 rpm with a discharge of approximately 6 L s^{-1} or 0.85 m s^{-1} with suction and discharge pipes of DN 110 mm, PN 10 HDPE.

The original pump was moved in late 2009 to improve performance while pumping from ports 3 and 4. The new location also minimised the additional pipe required to discharge to the site of the drying bays.

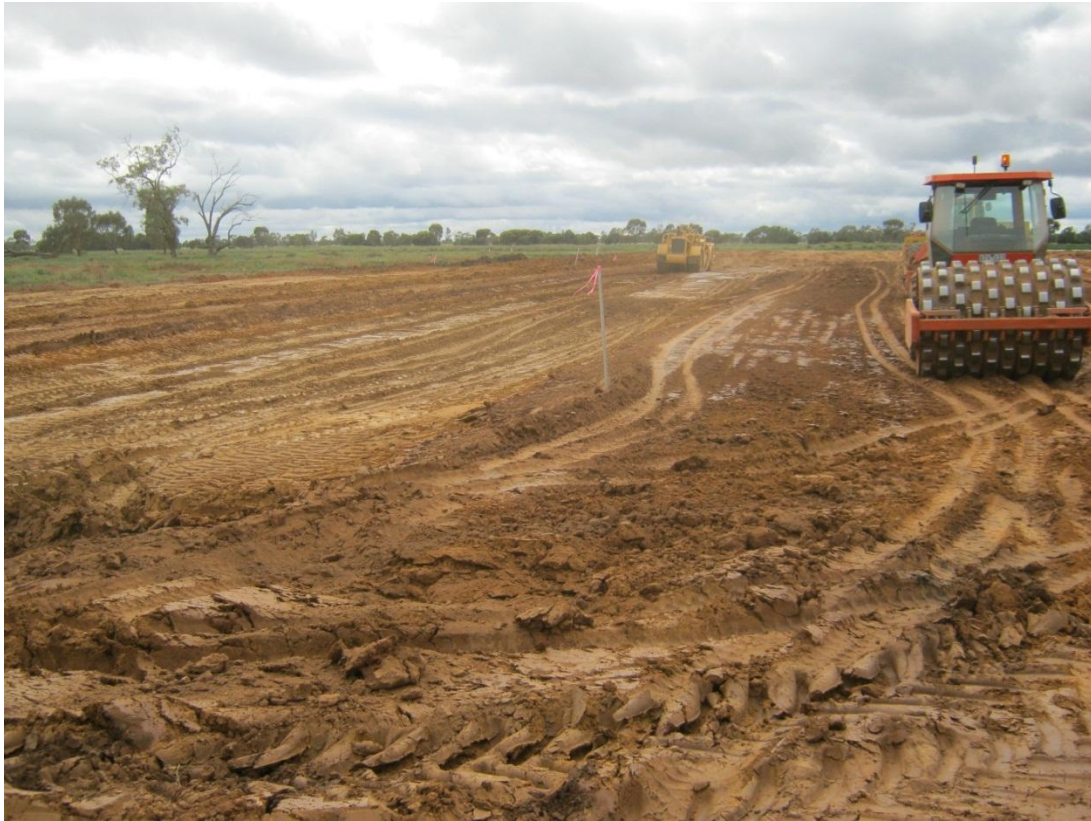
Figure 4: Earthworks underway for drying bays

Earthworks were completed in late February 2011 followed by installation of the delivery pipework over the following weeks. Figures 4 and 5 show the bays during construction and then at completion.

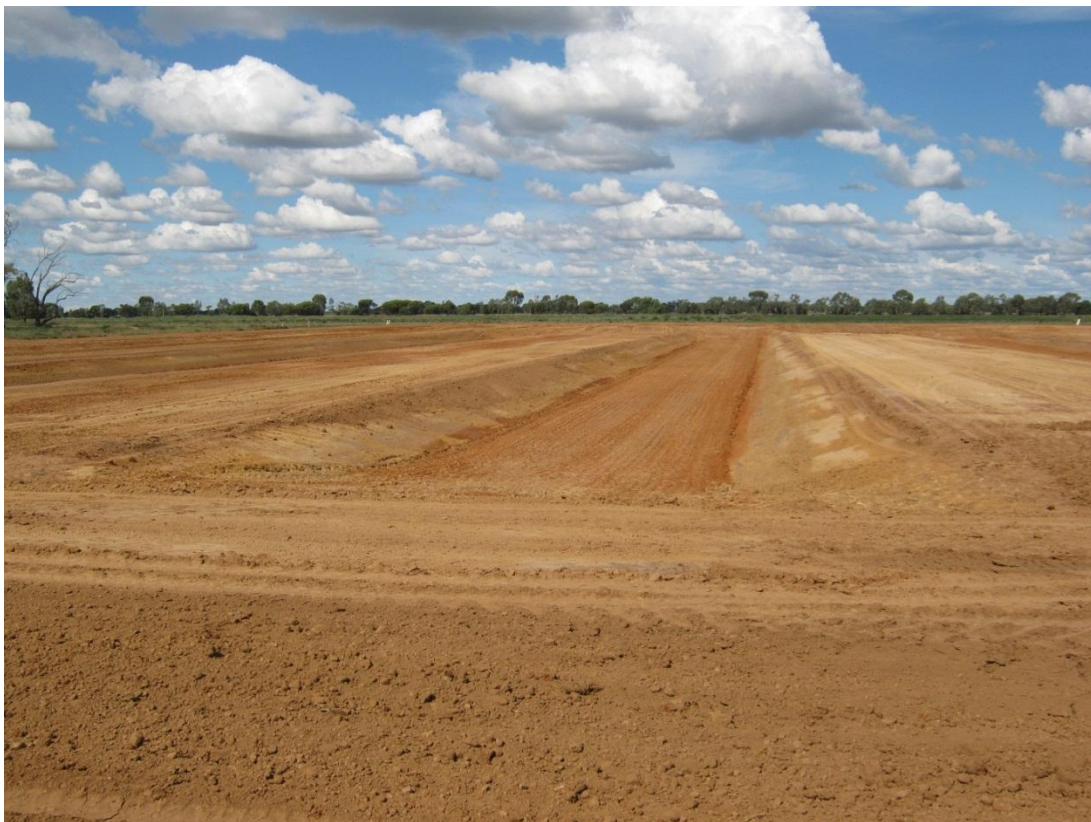
Figure 5: Completed drying bays, February 2011

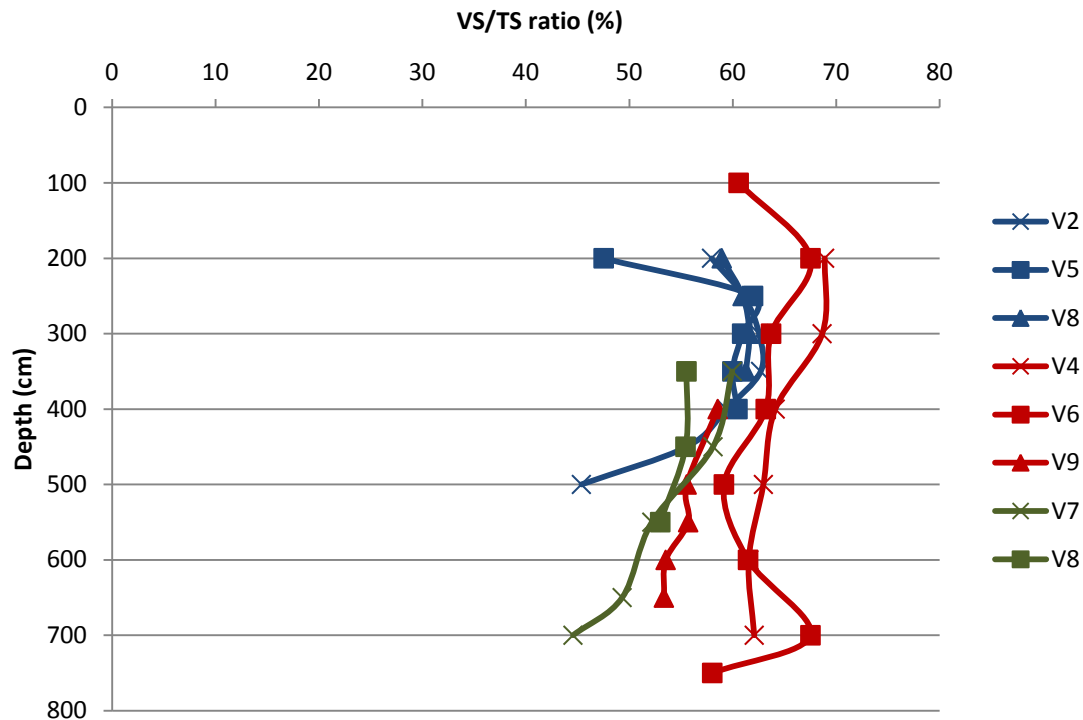
Figure 8: VS/TS ratio with depth; 2009 (blue), 2010 (red), 2011 (green)

Figure 8 confirms that there generally is a reduction in the VS/TS ratio with depth; the lower layers having been resident longer and undergone greater decomposition.

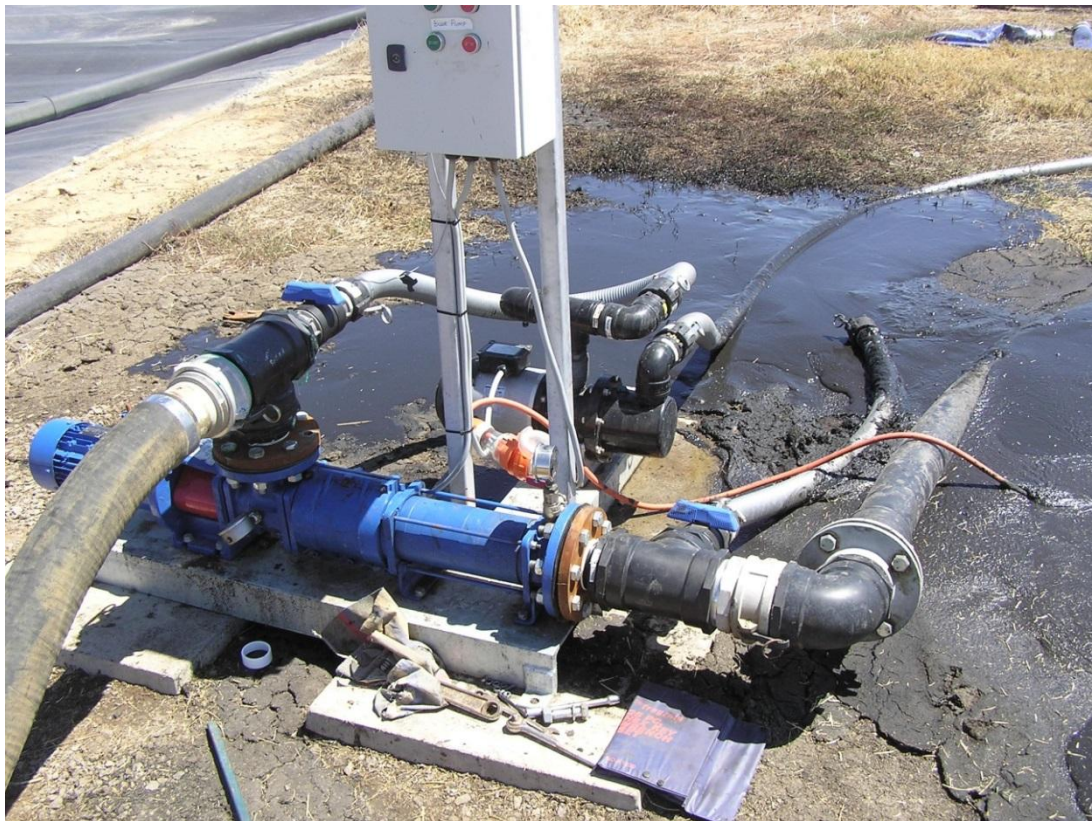
That process took much longer than anticipated with a number of pumps being investigated, and even trialled, before being ruled out. A replacement helical rotor pump was commissioned in February 2012 (Figure 10). The arrangement utilised two pumps – one pump (blue in Figure 10) to extract sludge from the CAP and direct it to the drying beds, the second pump (black) to pump green water from the winter storage to backflush the suction or purge the delivery line.

Figure 10: Replacement desludge and backflush pumps, February 2012

There were a number of problems with the replacement pump. The motor driving the desludge pump was initially under-powered and while it was subsequently replaced with more powerful unit, that unit was still prone to overheating. More critically, it was not able to move sludge at sufficient velocity to keep the solids in suspension. It is thought that the low velocity achieved (0.85 m s^{-1}) may have been allowing solids to settle in the 430m of largely horizontal discharge pipe, creating excessive back pressure which the single stage pump was unable to overcome.

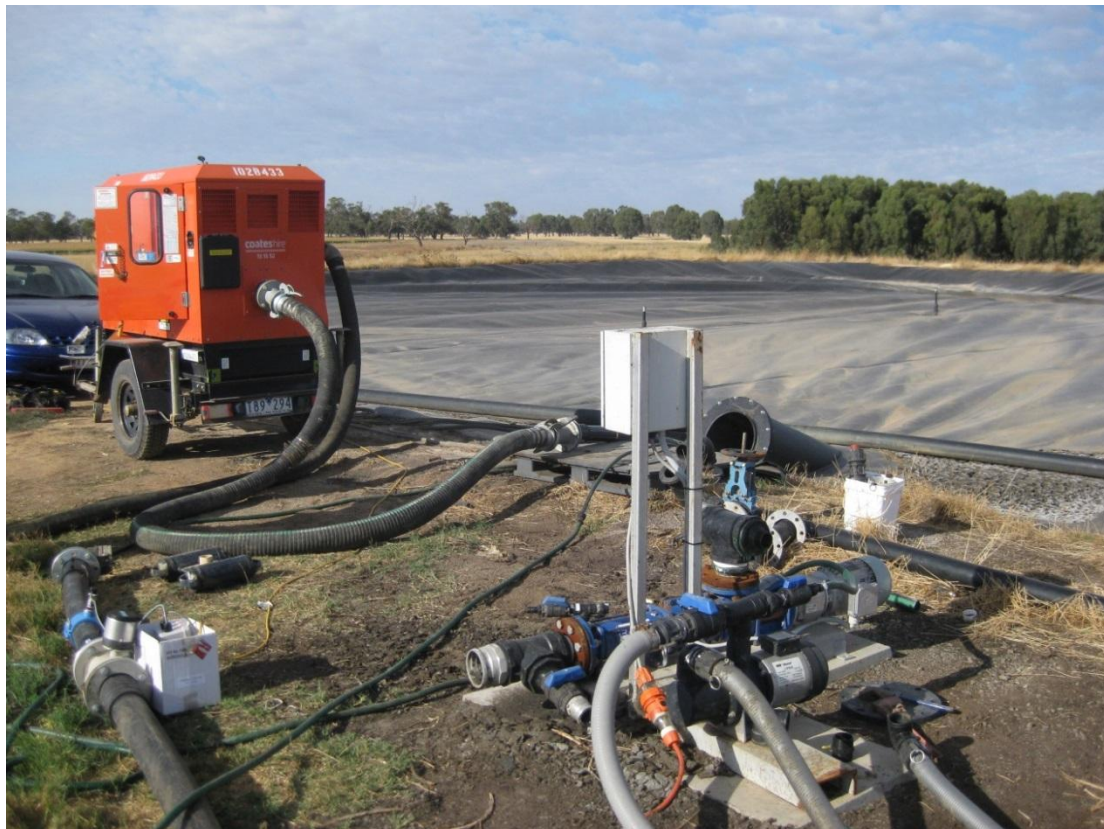
Bears Lagoon management then hired a trailer mounted, diesel-driven centrifugal dewatering pump (Allight CD100MSA) to attempt to extract sludge from the CAP (Figure 11). This arrangement was more successful and the drying bays were filled for the first time in late October 2012. It is noted that the TS content was variable and not representative of in-situ material due to the need to use effluent to dilute the recovered sludge and that no material was recovered from deeper than mid-depth.

Figure 11: Hire pump operating from the inclined access sleeve, February 2013

It must also be noted here that subsequent trial work completed using this pump as part of Australian Pork Limited Project No. 2012/1029 found that the pump was limited to a maximum head of around 25 m (Appendix B) and would therefore not be able to deliver sludge with a solids concentration exceeding approximately 7% given the friction losses in 430 m of delivery pipe. The report on APL project no. 2012/1029 is expected to provide further discussion of these issues.

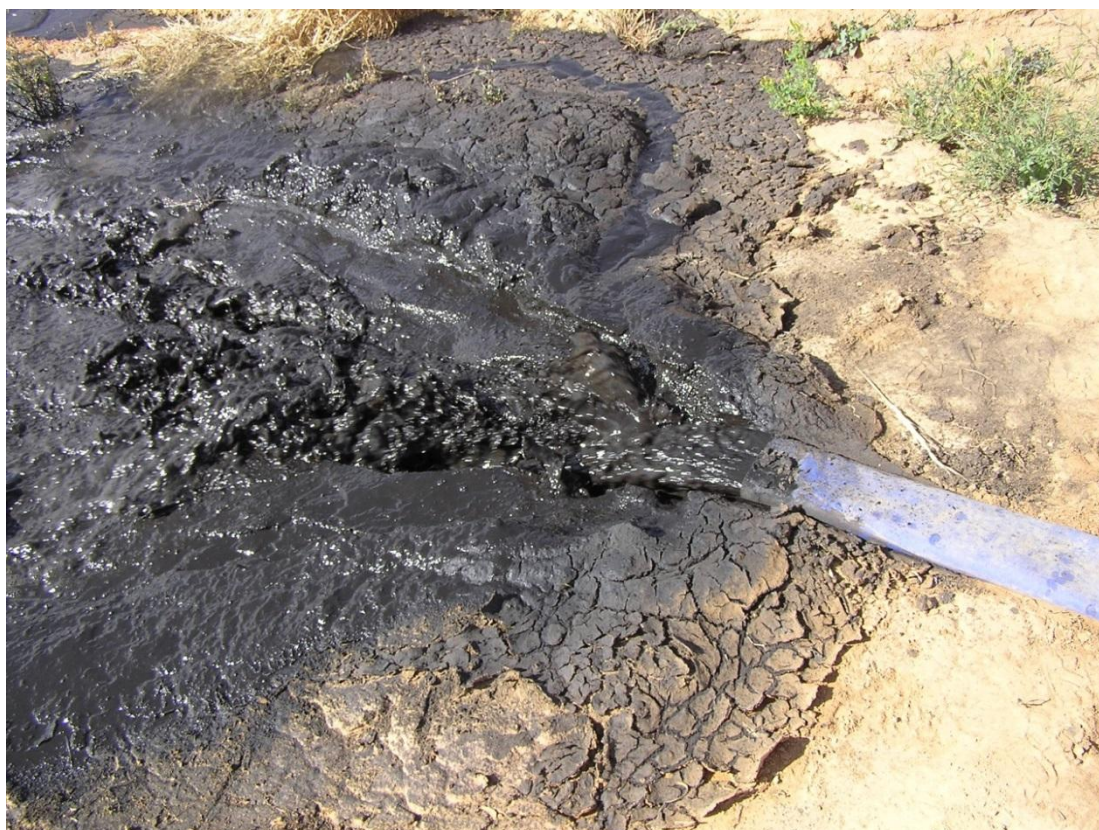
Figure 12: Filling the drying bays, October 2012

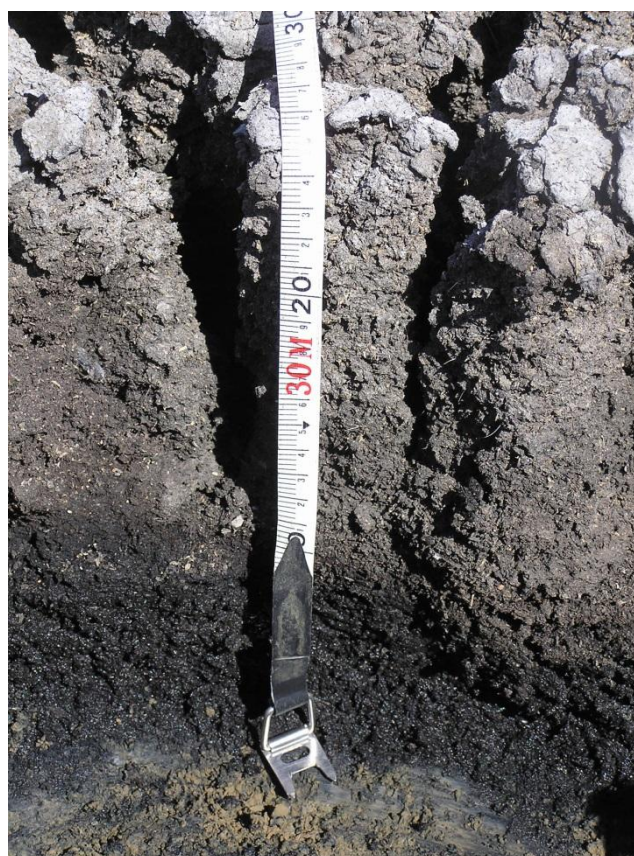
Over the remaining length of each drying bed, the top 150 mm were reasonably consistent; light, dry (76% dry matter) organic solids that had undergone significant shrinkage leaving a columnar structure (Figure 14). Underneath that top 150 mm, any material was moist (31% dry matter). The depth of solids decreased with distance from the inlet.

Figure 14: 150 mm of dry manure solids over 100 mm of moist material (test location M2)
