# **Low Cost Methane Capture and Combustion from a Piggery Effluent Lagoon**

**Final Report**  
**APL Project 2009/2307**

**August 2013**

**Rivalea Australia**  
Ian Longfield  
PO Box 78  
Corowa NSW 2646

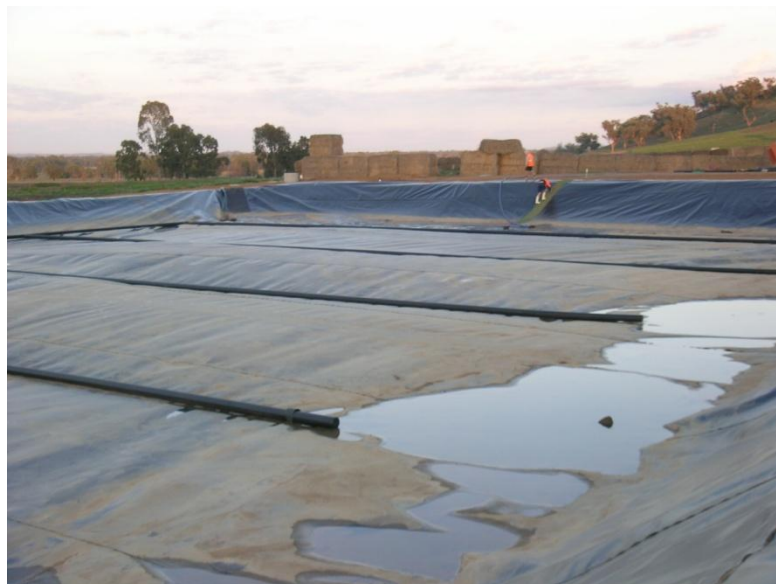
The original cover was installed using a ballast method consisting of 100 mm poly pipes filled with concrete. One lateral connector was placed on the southern side of the lagoon with fingers laid across the cover. This design proved to be inadequate as the ballasts did not hold the cover in place sufficiently to provide enough positive pressure to push the gas out through the flares.

**Ballast method**

Some major lessons were learned from the fire and the design for the new cover was subsequently changed.

- New water filled ballast system with a rib cage design
- Installation of a 2.2kW specialist biogas blower both for flaring and venting
- Installation of a bank mounted automatic emergency vent
- Larger gas evacuation takeoff (200mm) to reduce pressure drop to less than 10 Pa at a flow rate of 200m<sup>3</sup>/h
- Rigorous commissioning regime that included inflating the cover to prove operation of the automatic vent

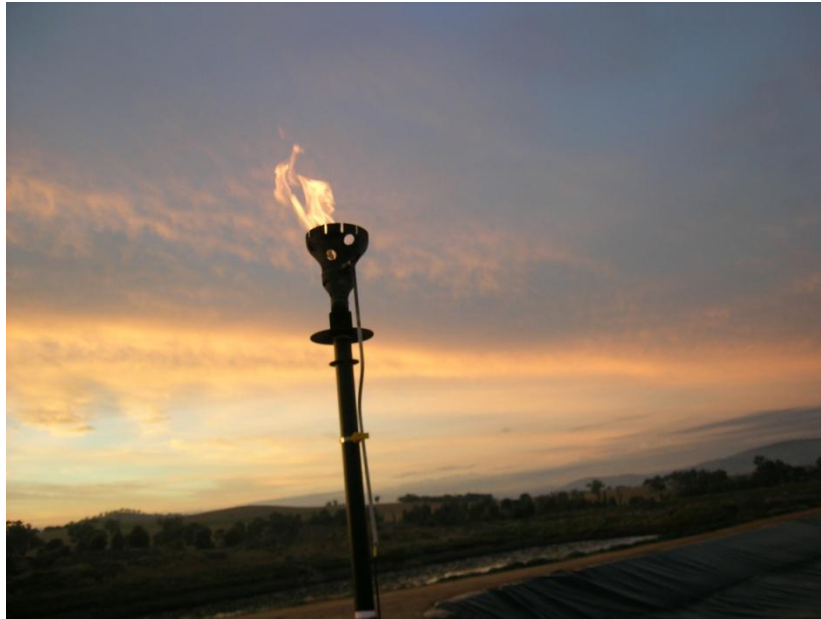
The flares operated on positive pressure from within the cover commonly referred to as a 'lazy' flame. This meant that the gas flowing to the flares was limited by the cover pressure which is only ever marginally above atmospheric pressure. This very limited pressure differential proved to be inadequate to allow gas to evacuate at a similar rate to production.

**Open flare without wind shroud**

- Thermocouples installed in each flare to record a flame temperature greater than 500 Deg C. This was only achieved with the installation of wind shrouds to enable the thermocouples to be positioned in a steady flame stream.

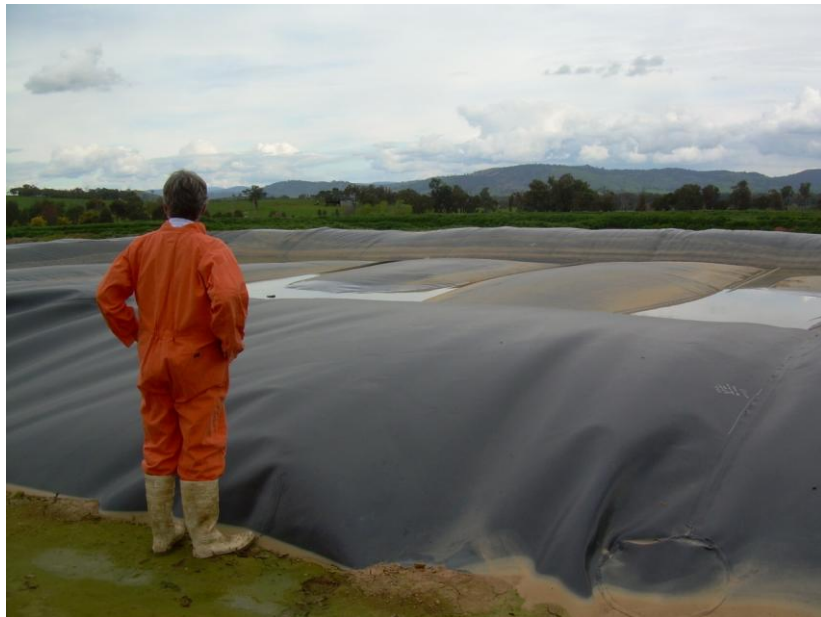
**September 2010 gas builds up under the cover. Ballasts still in place.**

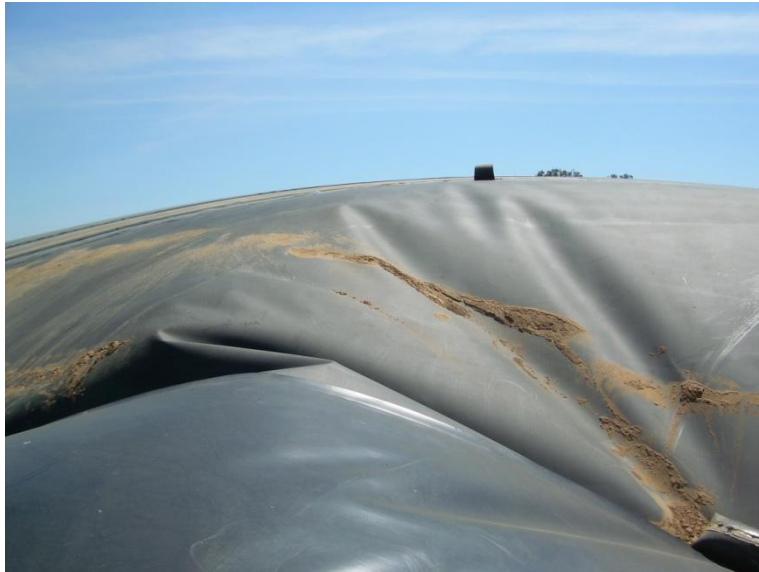
Around September/ October 2010, the cover inflated to the point where the ballasts slipped from their anchor straps, further reducing any downwards pressure on the cover.

**October 2010 – Pressure had built up in the cover to significantly alter the shape of the cover which caused the ballasts to slip out of the anchor straps. This then allowed the cover to inflate even further**

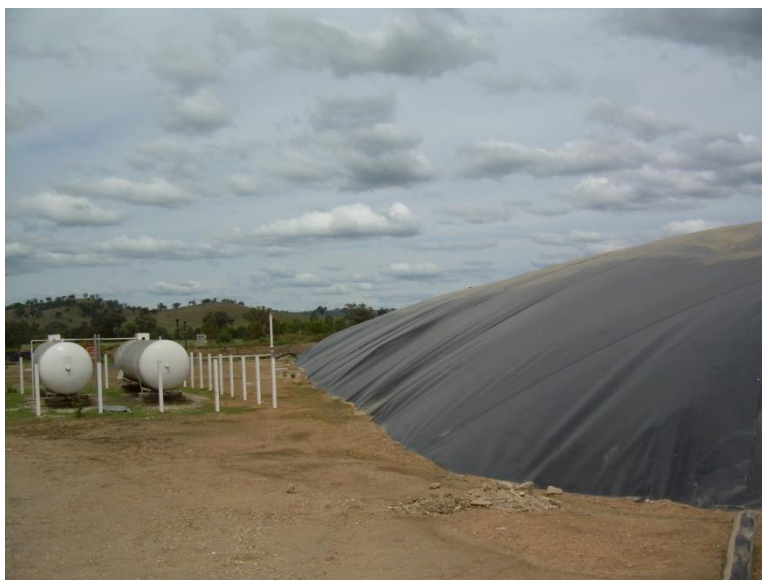
The contractors returned to the site on January 31 2011 to reinstall the ballasts and anchor them in place. The contractors were hauling the ballasts back in place using ropes when the cover was ruptured at its peak and caught fire. The ignition source is uncertain, but is believed to have possibly come from an appliance being used in a pig shed, some 50m away.

As the fire spread, the cover was further ruptured giving rise to a very large plume of burning biogas. Fortunately, both the contractors themselves and a Rivalea manager saw the initial fire and ran from the area, narrowly avoiding a potentially deadly situation.

The plume of burning gas set fire to a pig shed roof (sandwich panel) and completely destroyed the cover. Damage to the flaring equipment was minor however the proximity of two large LPG tanks was of major concern to the fire brigade.

**16 November 2010 - having the cover fully inflated was dangerous as it allowed a large volume of gas to accumulate. Note the proximity of the LPG tanks. The cover was at a similar level of inflation when it was ruptured and subsequently caught on fire.**

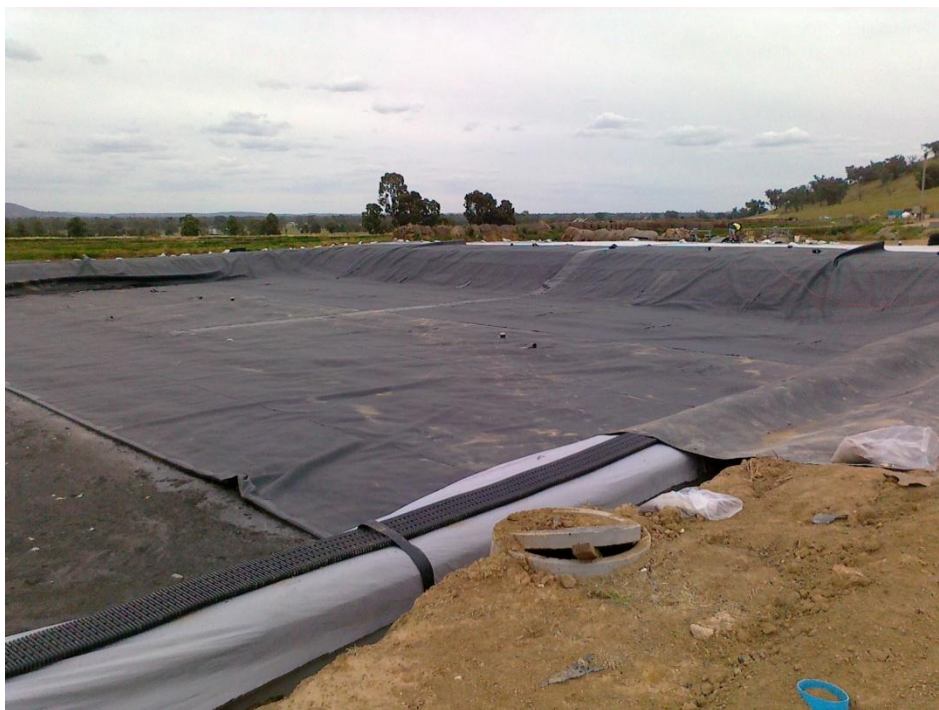
**New cover being placed over the lagoon.**

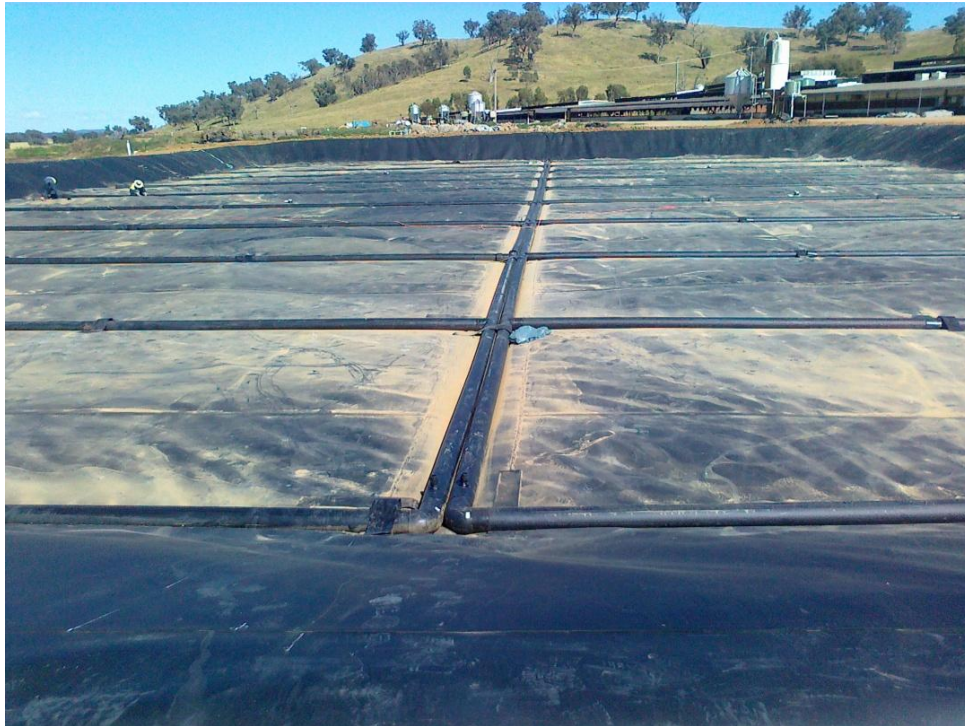
**New ballast method included a rib-cage style system with central spine placed in the centre of the lagoon. The ballasts are filled with water which is topped up from time from a bank mounted filling hose. The new ballast has a design capacity of 14 tonnes.**

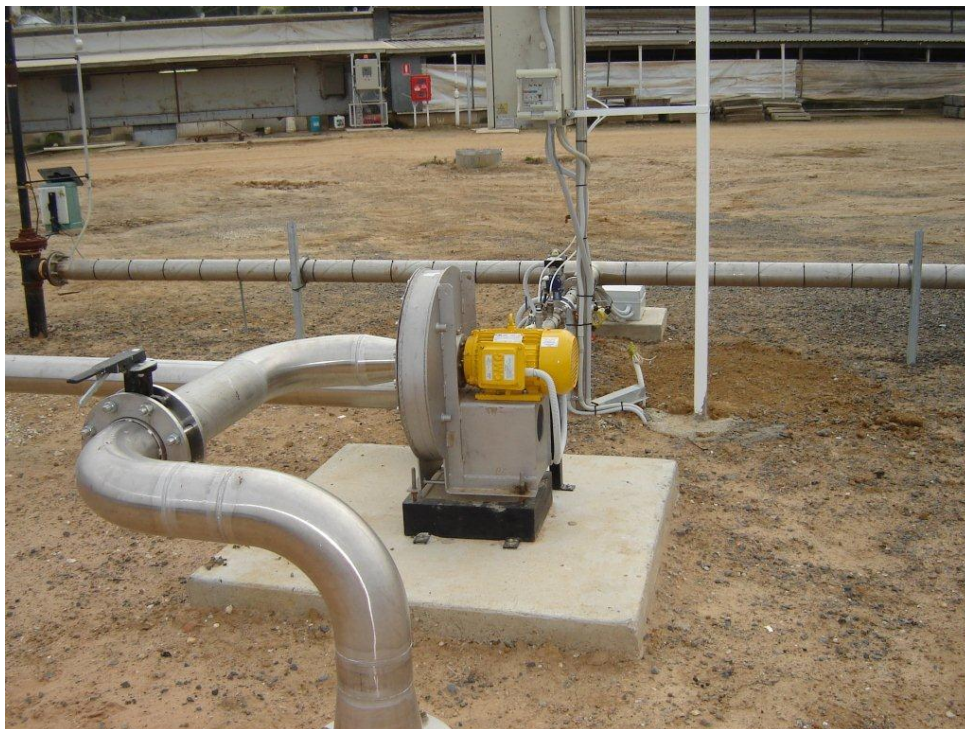
**Installation of blower capable of 500m<sup>3</sup>/h. The main control cabinet has now been moved to well beyond the hazardous area and can be seen in the background.**

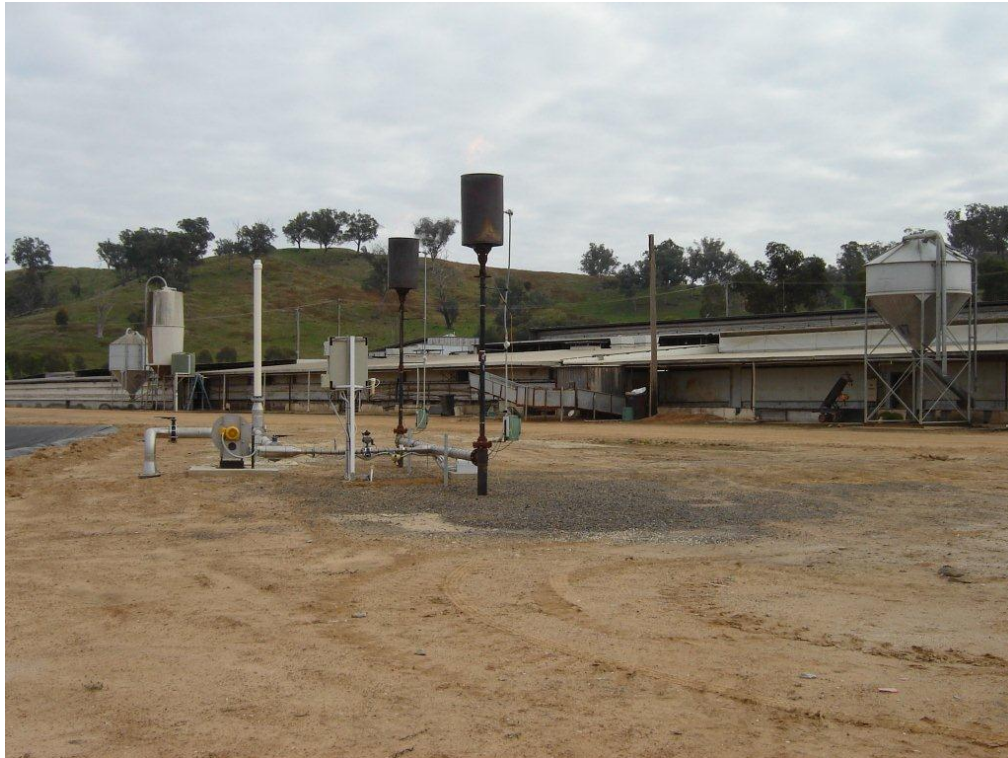
**Existing flares fitted with wind shrouds and thermocouples.**
