Queensland Sedimentation and Evaporation Pond System (SEPS) Trial

Final Report
APL Project 2009/2248

June 2013

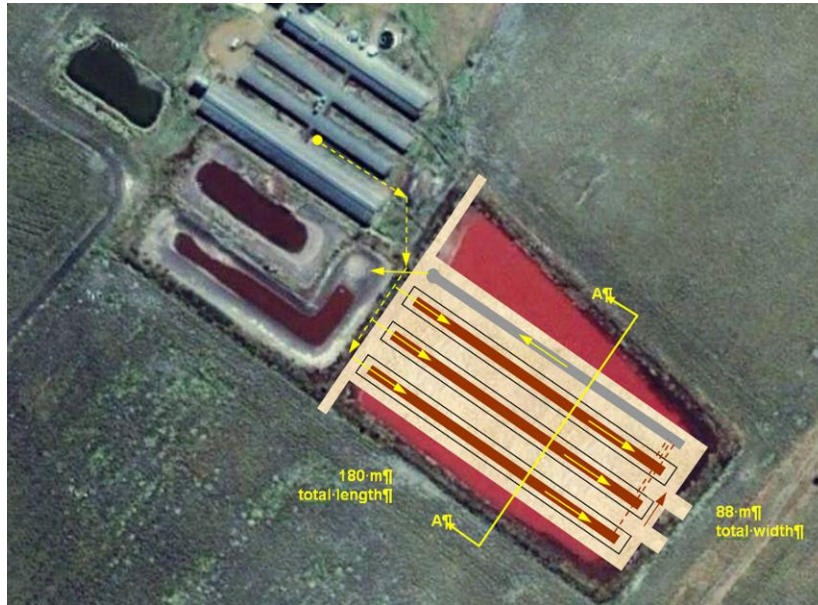
Figure 1: Aerial photograph of the piggery with the proposed SEPS overlaid.

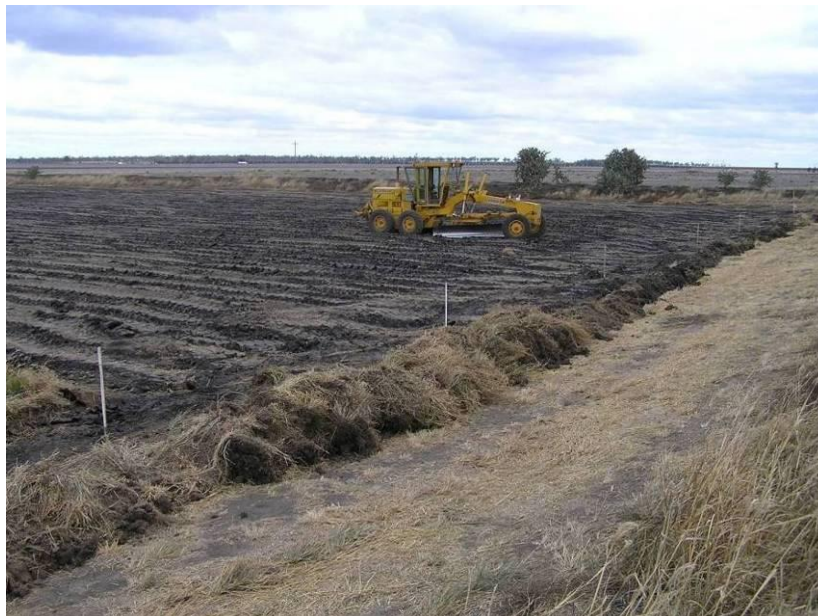
Figure 2: Stripping piggery solids from the base of the disused effluent evaporation pond in preparation for construction.

The earthworks for the SEPS were carried out over a 2 week period from 24 June to 6 July 2010. The machinery used in the earthworks construction included a scraper, dozer, grader, vibrating pad foot roller and water truck. As shown in Figure 1, the SEPS were constructed within a disused effluent evaporation pond. Figures 2 to 6 show various stages of the SEPS earthworks construction.

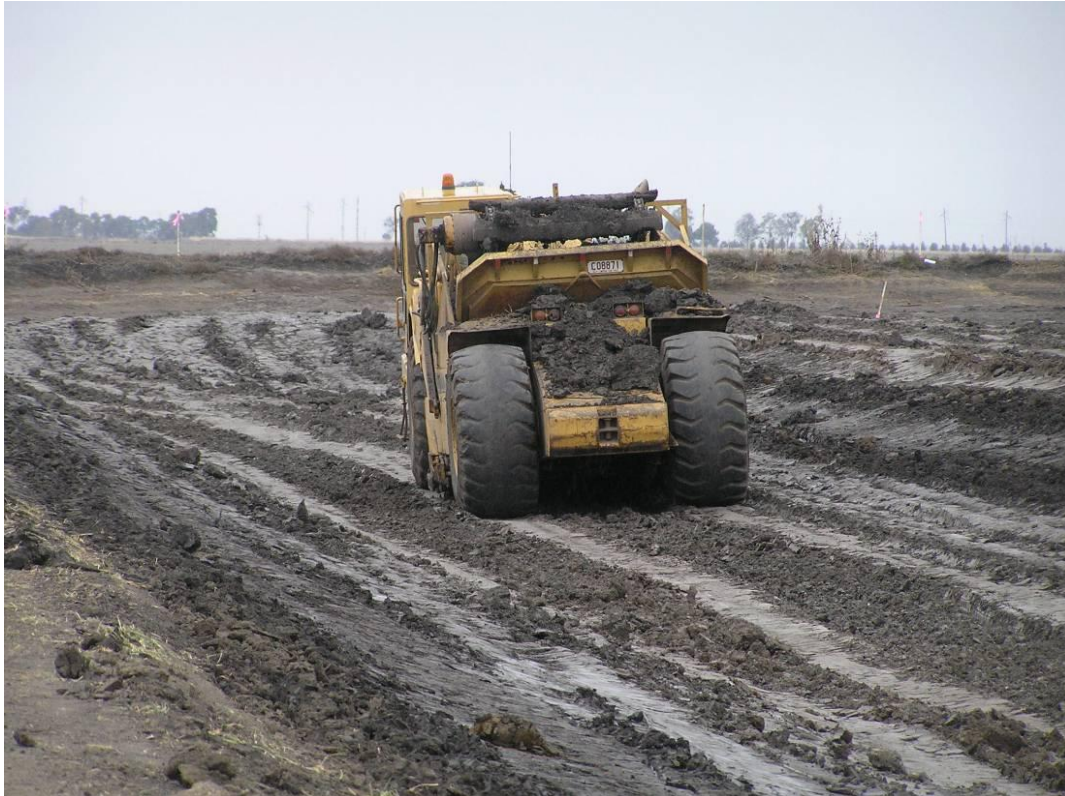
Figure 3: A scraper was used to remove material from the base of the SEPS channels for placement on the banks.

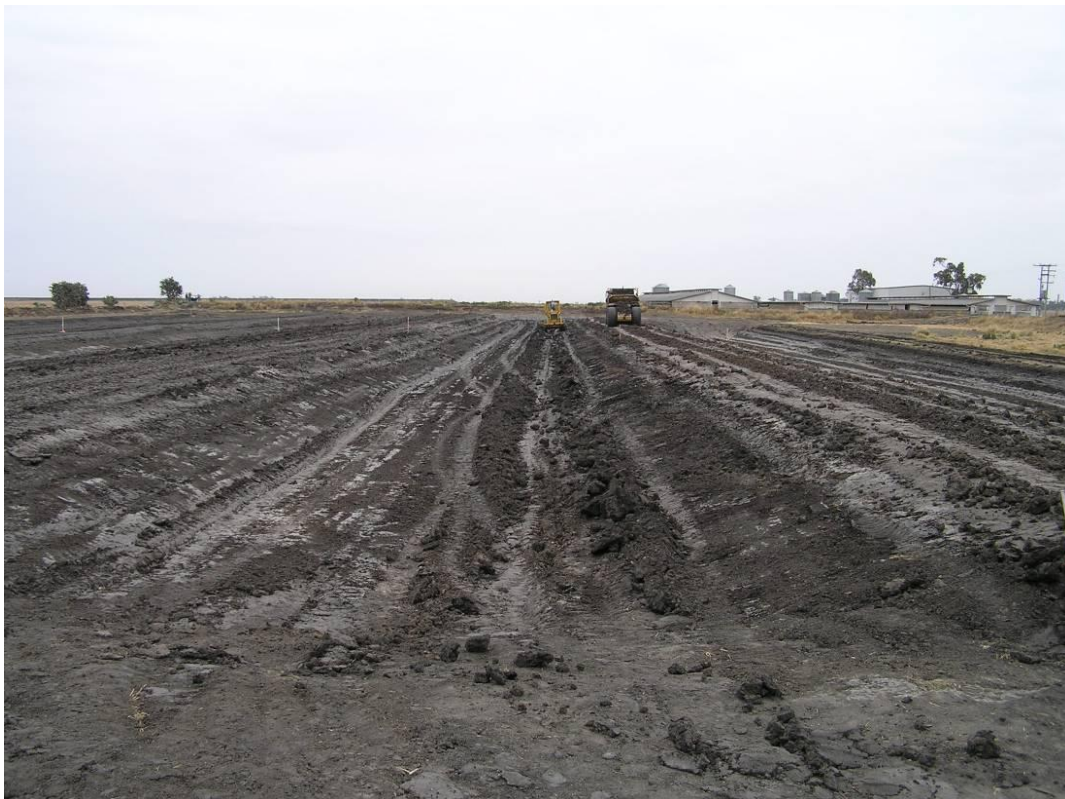
Figure 4: A grader was used to trim the earthworks following placement with the scraper and compaction using the vibrating pad-foot roller.

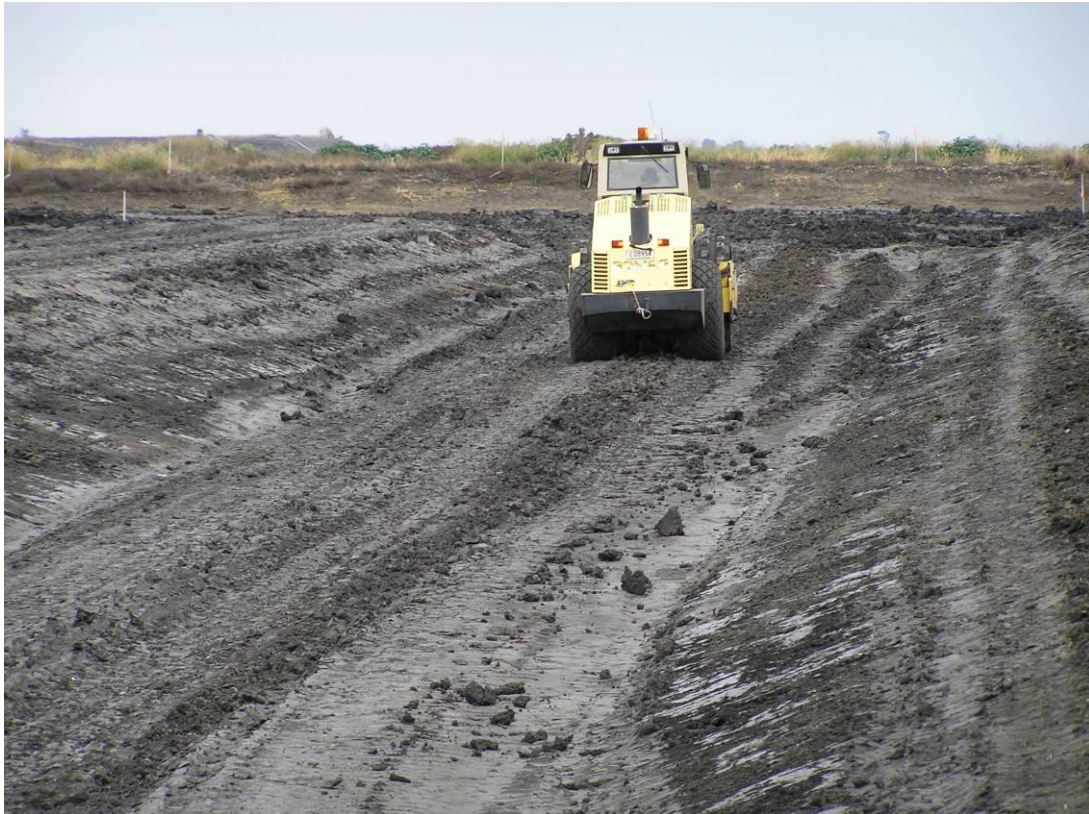
Figure 5: Vibrating pad foot roller compacting the base of one of the SEPS channels

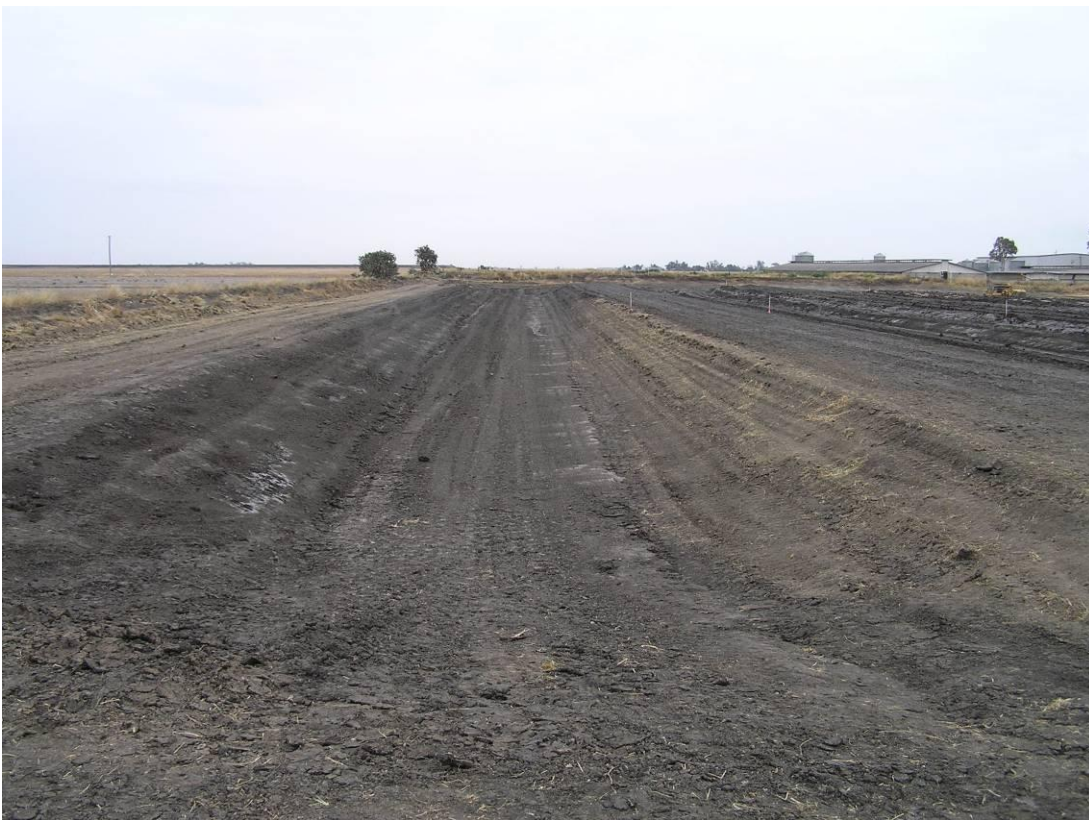
Figure 6: Completed SEPS channel.

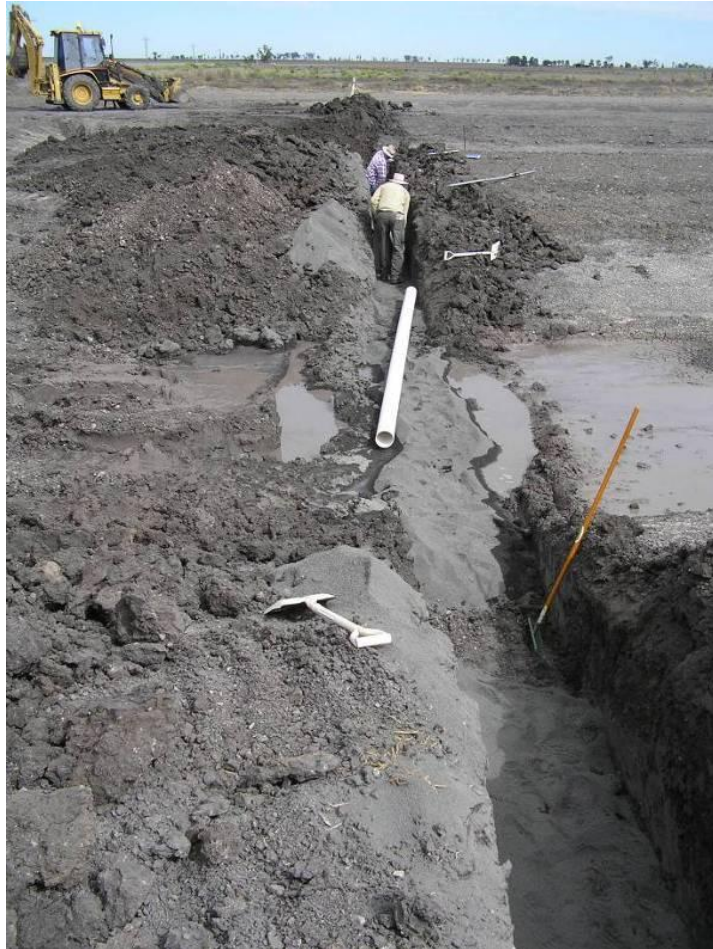
Figure 7: Laying individual 150 mm diameter PVC drainage pipelines from each of the SEPS channels to the return drain.

The SEPS drainage pipelines were installed on 5 August 2010. Separate 150 mm diameter PVC pipelines were installed from the lower (eastern) ends of each of the three SEPS channels, to the return drain. Each drainage pipeline was laid perpendicular to the SEPS channels, on a constant gradient of 0.5%, without any bends, to reduce the risk of blockages. A backhoe contractor was employed to assist with the pipe laying. A laser level was used to control the trench excavation and pipe laying process to ensure that a uniform pipeline gradient was achieved. Figures 7 and 8 show stages of the SEPS drainage pipeline installation.

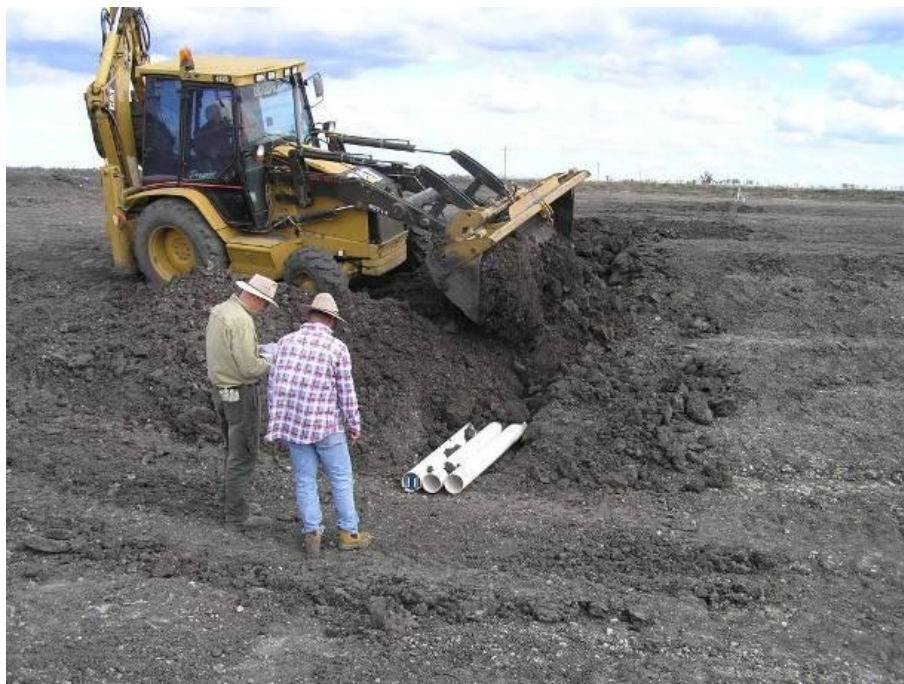
Figure 8: Backfilling the pipeline trench where the three SEPS drainage pipelines enter the return drain.

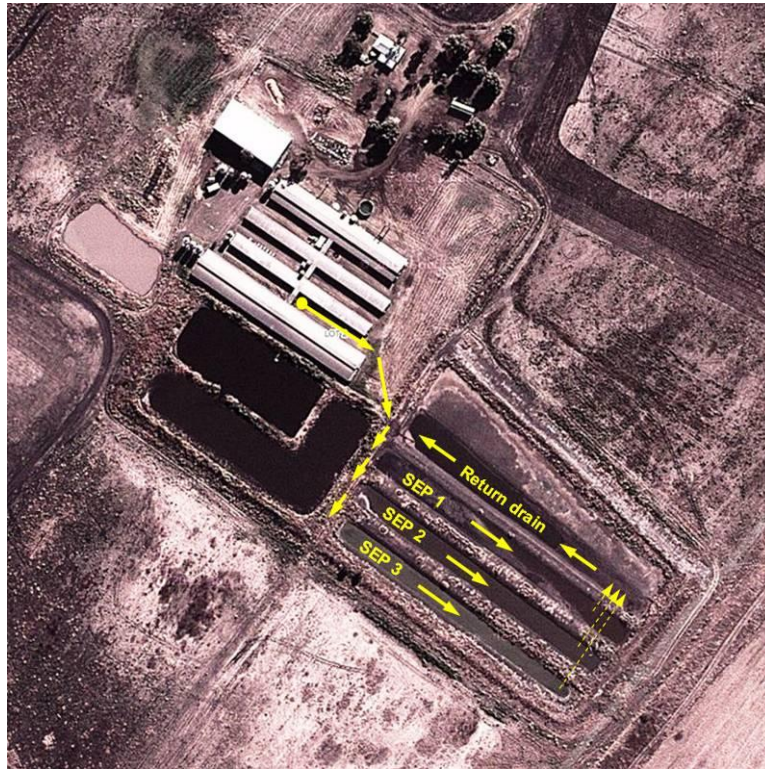
Figure 9: Aerial photo showing completed SEPS.

Figure 9 is an aerial photograph showing the completed SEPS. The drainage pipelines are shown as dotted lines near the eastern (downstream) ends of the SEP channels.

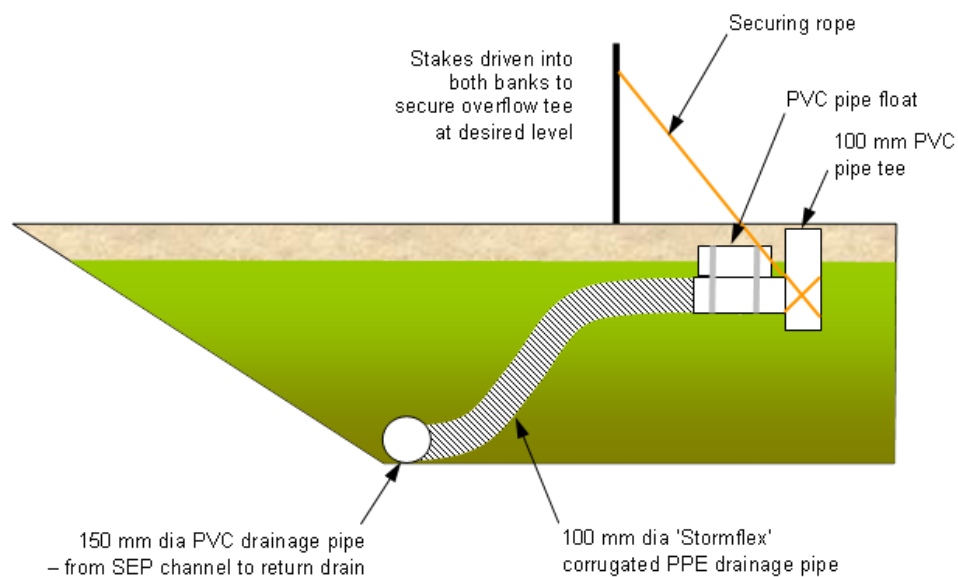
Figure 10: Schematic drawing of overflow arrangement initially installed on the first SEPS channel.

An adjustable overflow pipeline and fittings were initially installed on the upstream end of the first SEPS drainage pipeline, as shown schematically in Figure 10. This arrangement was intended to allow the first SEPS channel to fill up with raw effluent pumped from the piggery sheds, before overflowing by gravity through the SEPS drainage pipeline into the return channel.

The overflow arrangement was fitted with a tee on the upstream end to draw effluent from just below the surface, thereby preventing the entry of floating solids that could potentially result in blockages. The overflow tee was secured at the desired overflow level using ropes tied to stakes driven into the adjacent banks of the SEPS channel. At the end of the 6 month active filling cycle, it was planned to release the securing ropes, allowing the SEPS channel to gradually drain down to bed level. The float was intended to ensure that effluent was drawn from just below the surface during the drainage cycle, thereby minimising the export of settled solids into the return drain.

Due to the flexibility of the 'Stormflex' pipe, it was found that the overflow arrangement described above did not operate successfully. Air locks in the 'Stormflex' pipe frequently impeded drainage of the SEPS. Replacement of the 'Stormflex' pipe with less flexible pump suction pipe improved the overflow operation. Prior to commencing pumping of effluent into SEP 3, the overflow arrangement shown in Figure 11 was installed. This arrangement used a fixed 150 mm diameter PVC riser and tee to prevent floating crust material from entering the drainage pipe. This system was found to work relatively successfully.

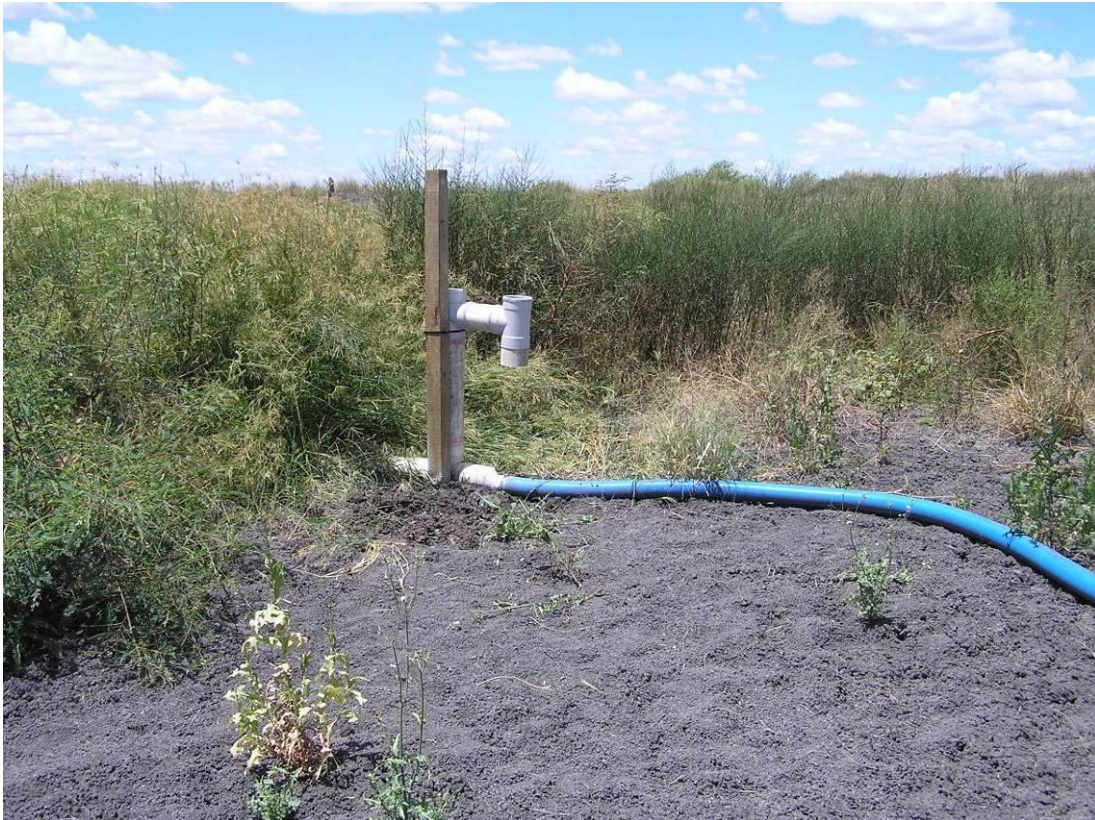
Figure 11: Revised overflow arrangement trialled in SEP 3 using 150 mm dia PVC riser and tee and 100 mm dia. flexible pump suction pipe.

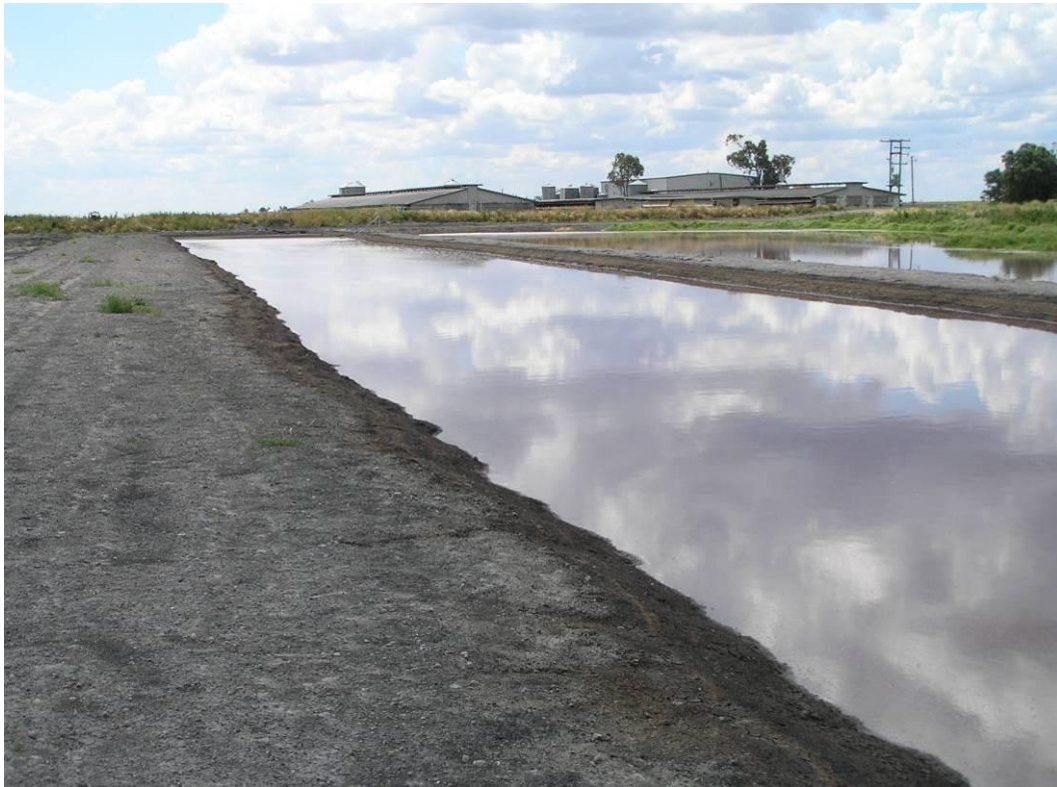
Figure 12: Photograph of the first SEPS channel and return drain on 5 November 2009, after approximately one month of active operation.

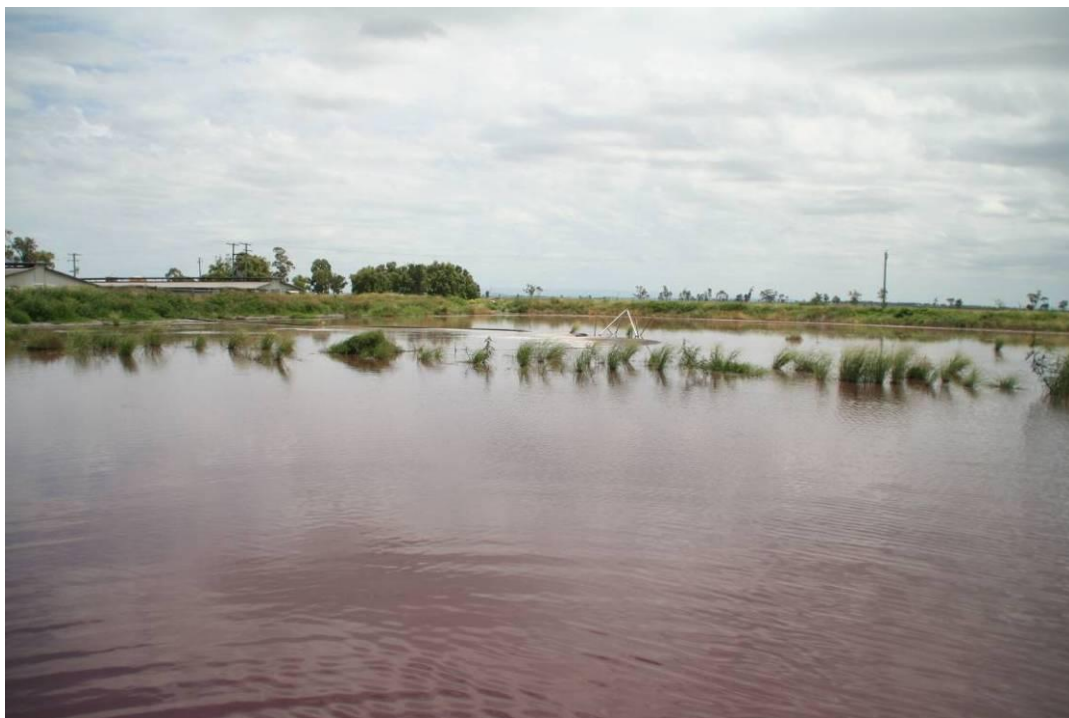
Figure 13: Photograph of the SEPS on 17 January 2011. All three SEP channels and the return drain were filled with effluent following the extreme wet conditions experienced over the summer of 2010-11.

Southern Qld experienced an extremely wet summer 2010-2011, which resulted in severe flooding of many areas. The December 2010 rainfall at Bowenville (Bureau of Meteorology Station No 41008) was 305 mm, the second highest December rainfall recorded since records commenced in 1889. The January 2011 rainfall was 217 mm, which exceeded the 97th percentile monthly rainfall for January. Under the extreme wet conditions, the piggery manager was forced to pump effluent into each of the three SEPS channels and the return drain, as all wet weather storage capacity available on the farm was full. Figure 13 shows the inundated SEPS on 17 January 2011.

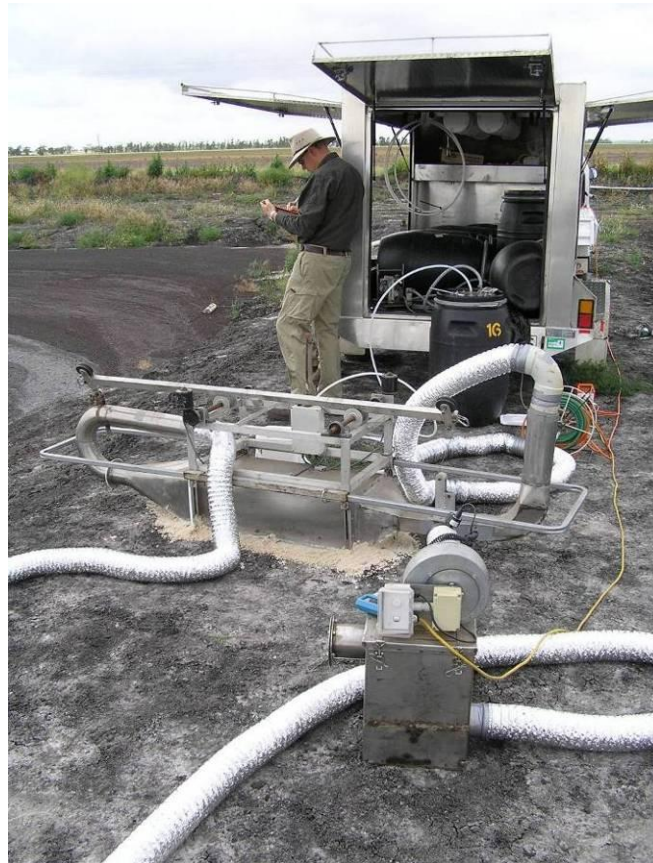
Figure 14: Collecting a blank odour sample using the Agri-Science wind tunnel positioned on a stainless steel sheet adjacent to the SEP channel (November 2011).

At the start of each sampling day, blank samples were collected by placing the wind tunnel on a stainless steel sheet that had been cleaned using acetone. Blank samples are required to demonstrate that the equipment does not contain any odour contaminants and to establish a baseline for comparison with the actual samples. Clean, slightly damp sand was placed around the perimeter of the wind tunnel base to minimise leakage.

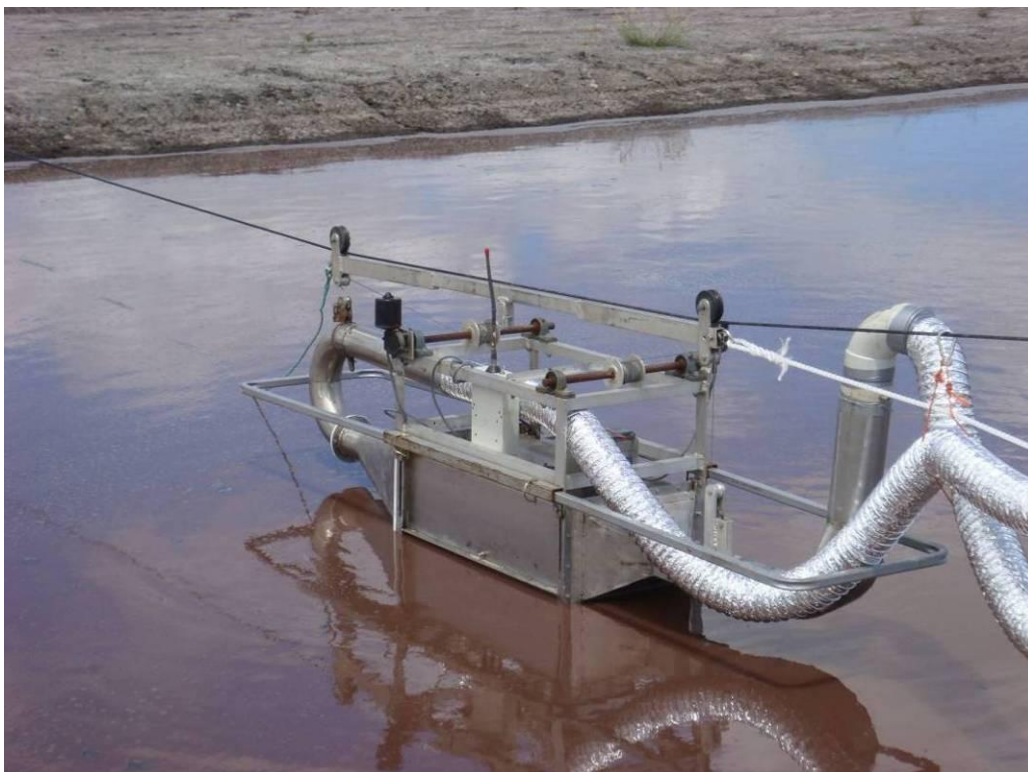
Figure 15: Wind tunnel collecting odour sample from near the eastern end of the SEPS channel (25 November 2010).

Figures 14 to 19 show examples of odour sampling using the Agri-Science Queensland wind tunnel.

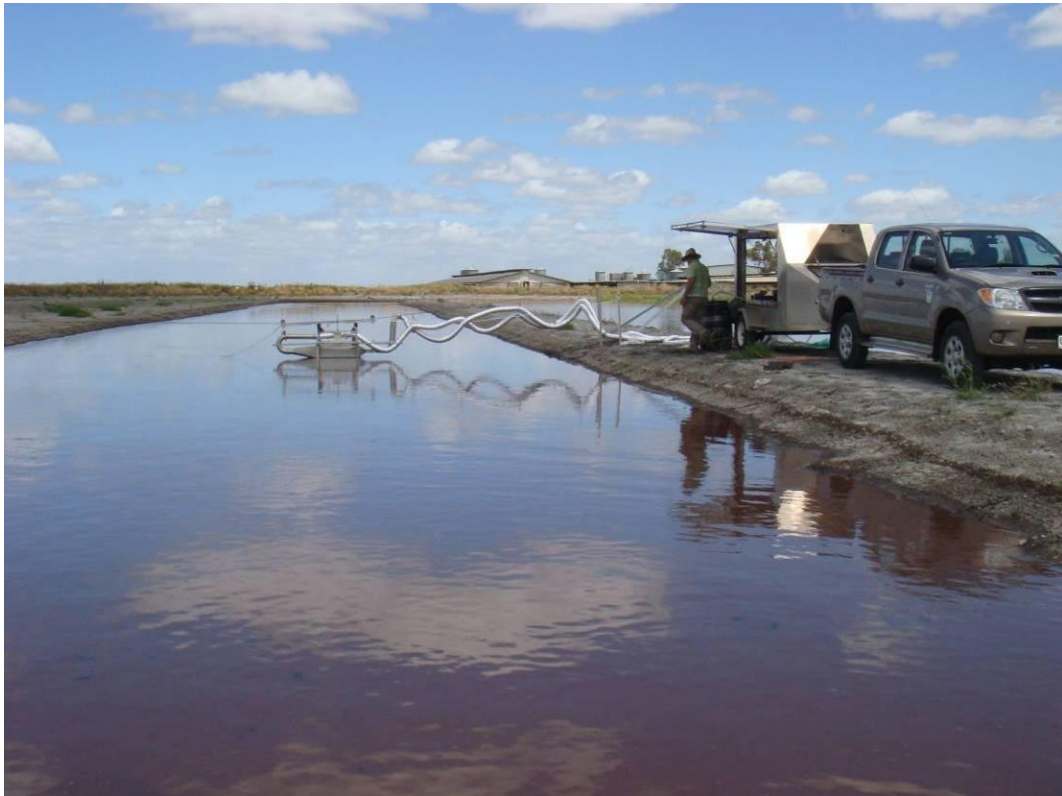
Figure 16: Odour sampling near eastern end of SEPS channel (25 November 2010).

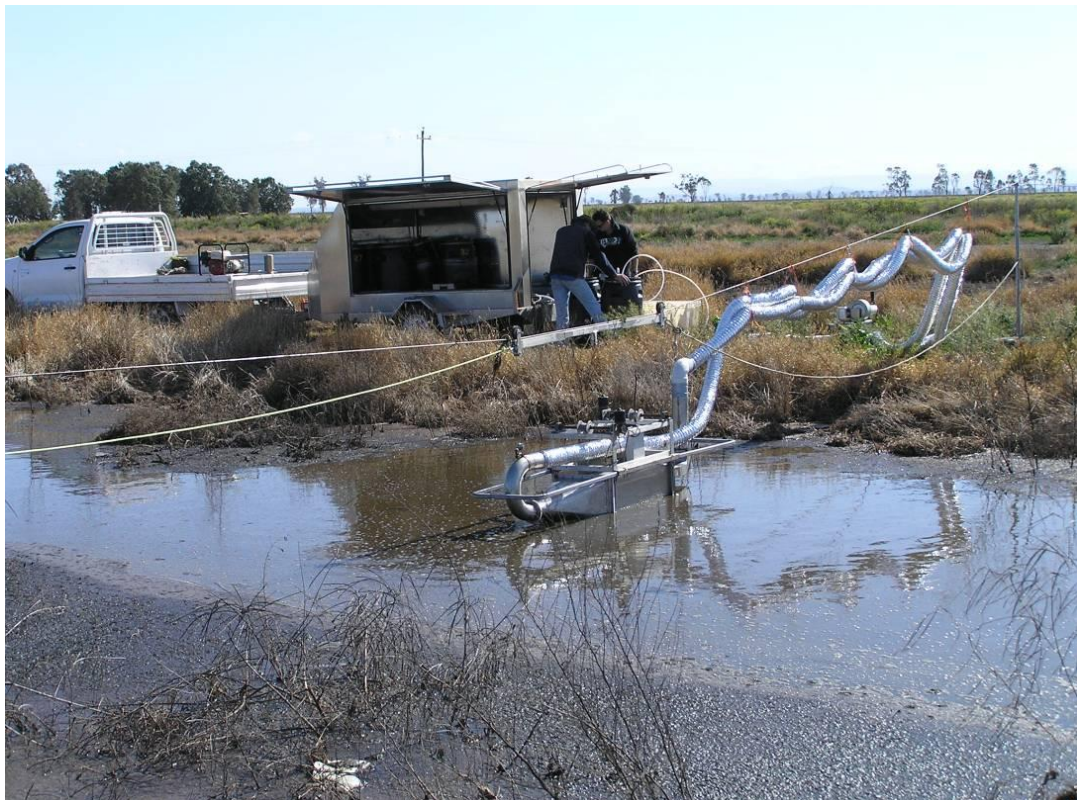
Figure 17: Wind tunnel collecting odour sample from near the western end of the SEPS channel, close to the location where the shed effluent enters the SEPS (28 August 2012).

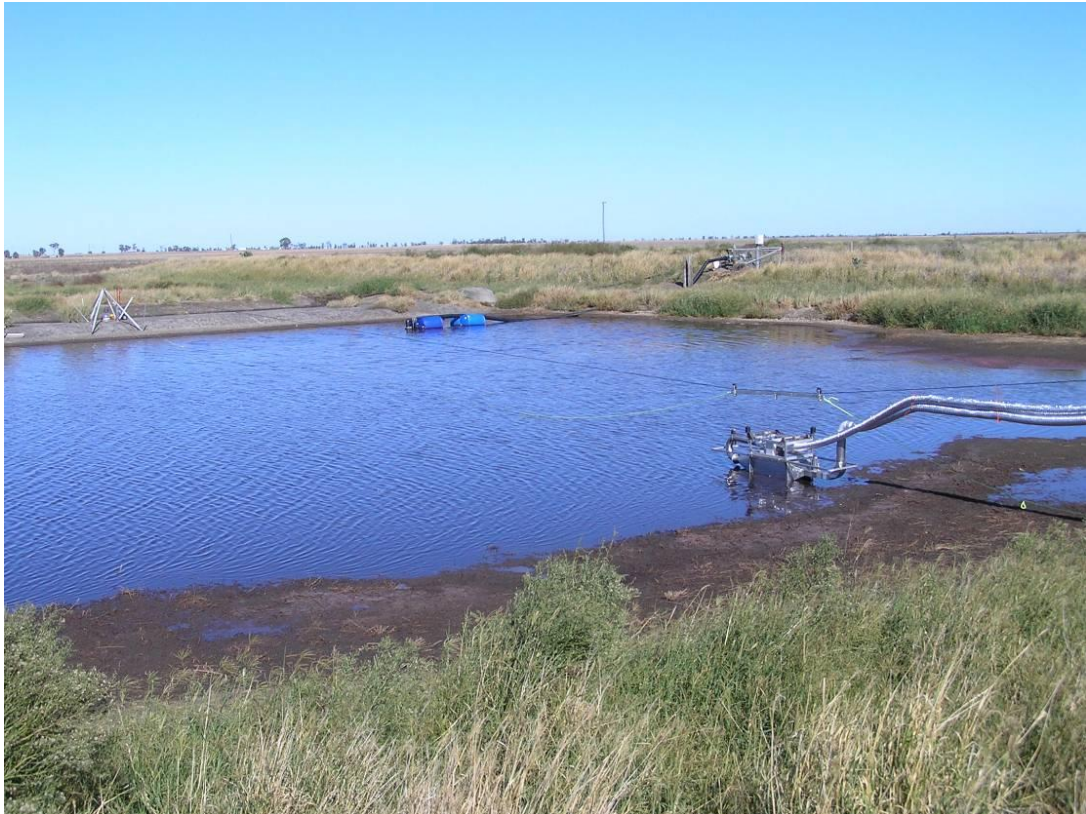
Figure 18: Wind tunnel sampling near the western end of the return drain (12 April 2012).

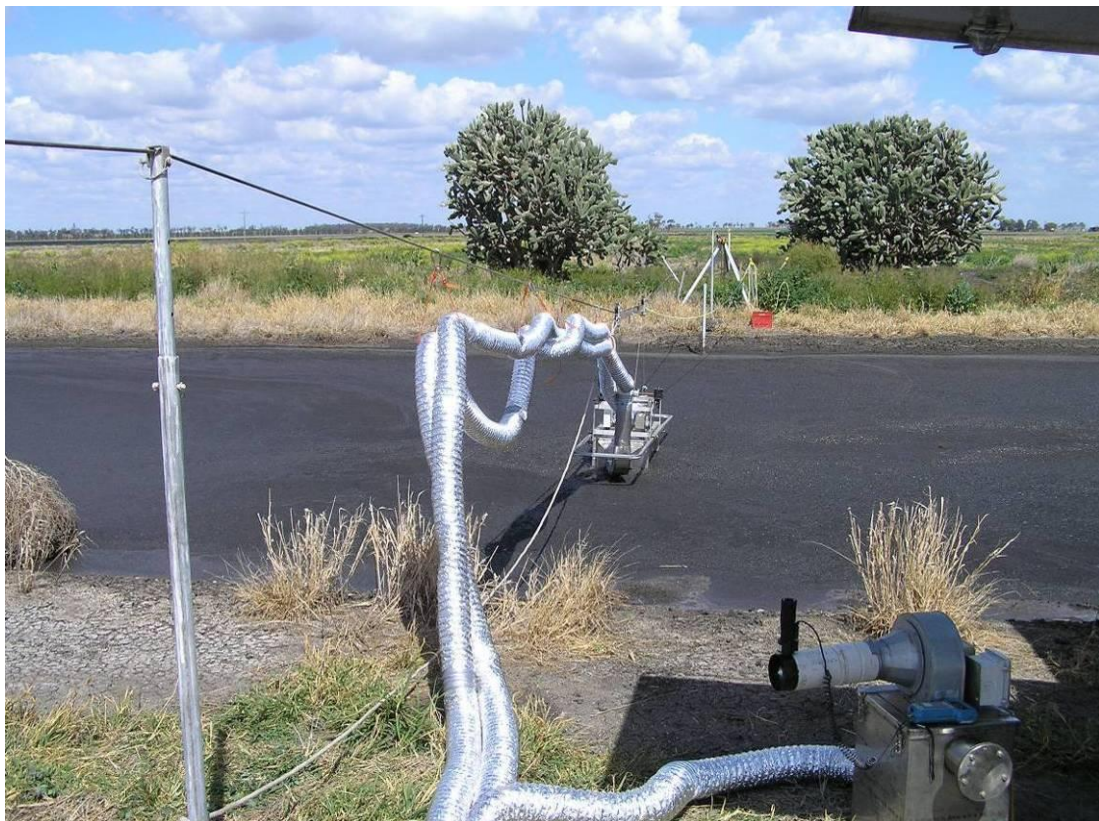
Figure 19: Odour sampling from the upstream end of SEP 3 (active SEP) on 28 August 2012 using the wind tunnel.

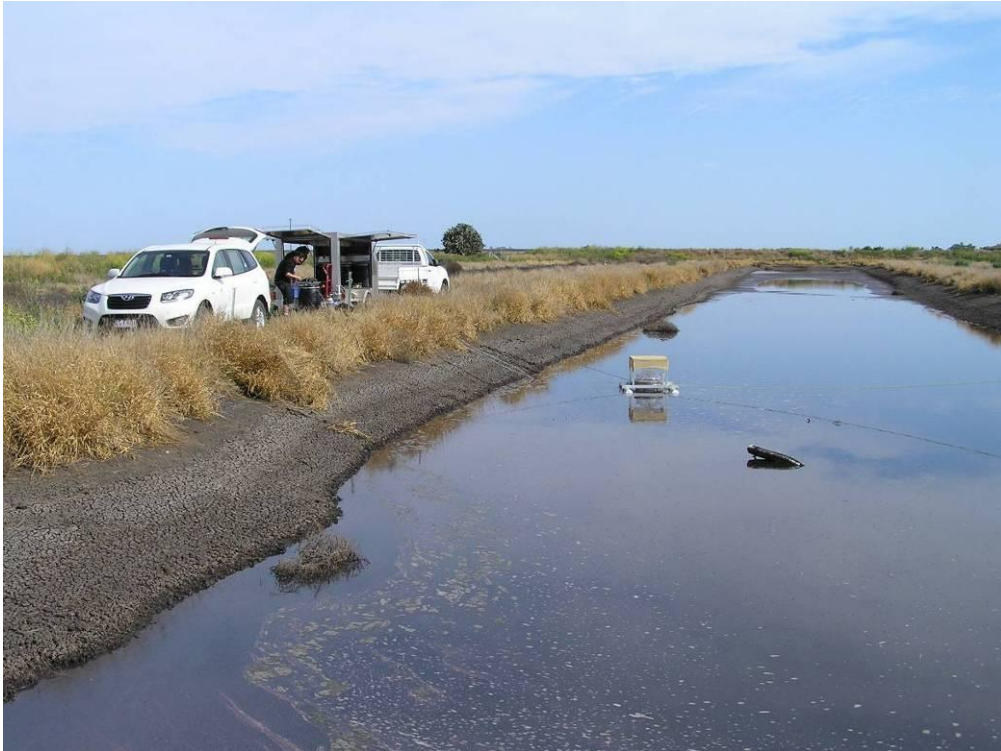
Figure 20: Odour sampling from the downstream end of SEP 2 (drying SEP) on 29 August 2012 using the flux chamber.

Photographs of odour sampling using the flux chamber are provided in Figures 20 to 23.

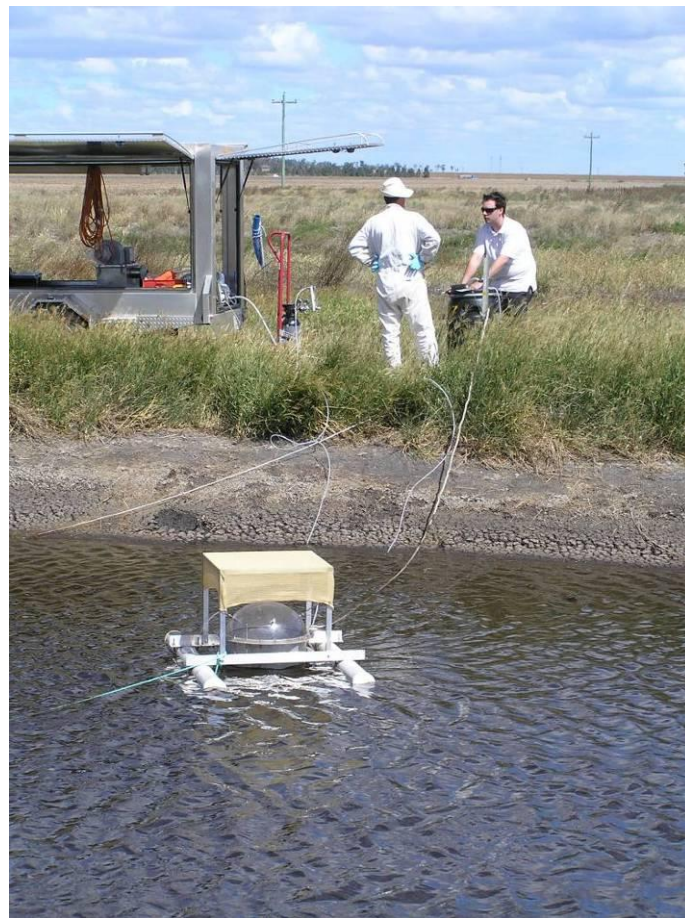
Figure 21: Odour sampling from the return drain using the flux chamber (12 April 2012)

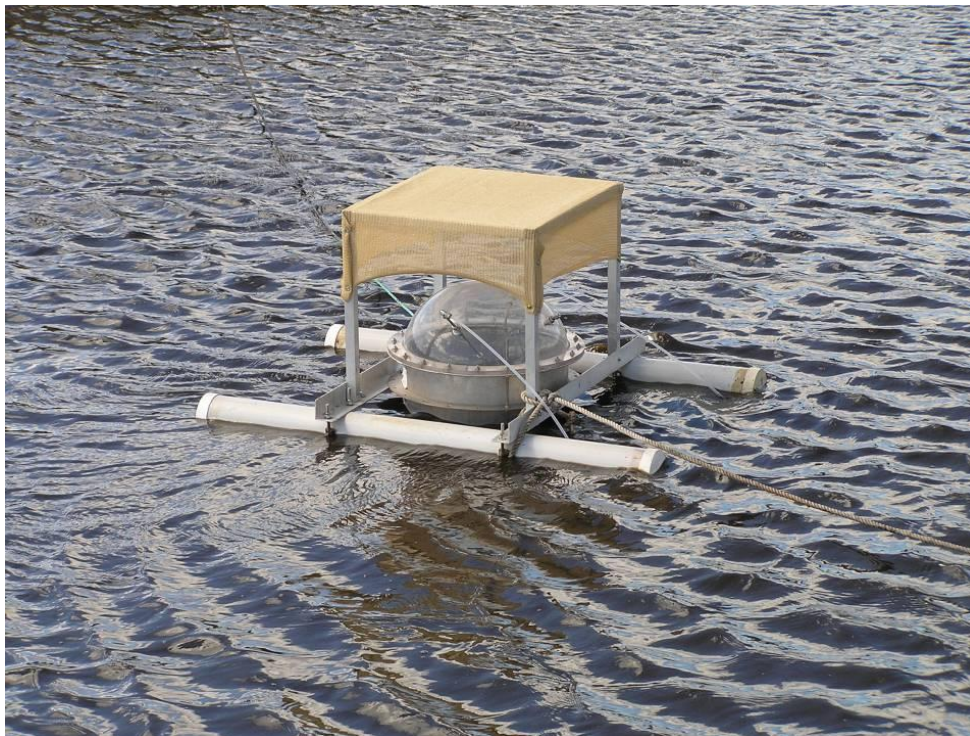
Figure 22: Close-up view of the flux chamber collecting odour sample from the return drain (12 April 2012).

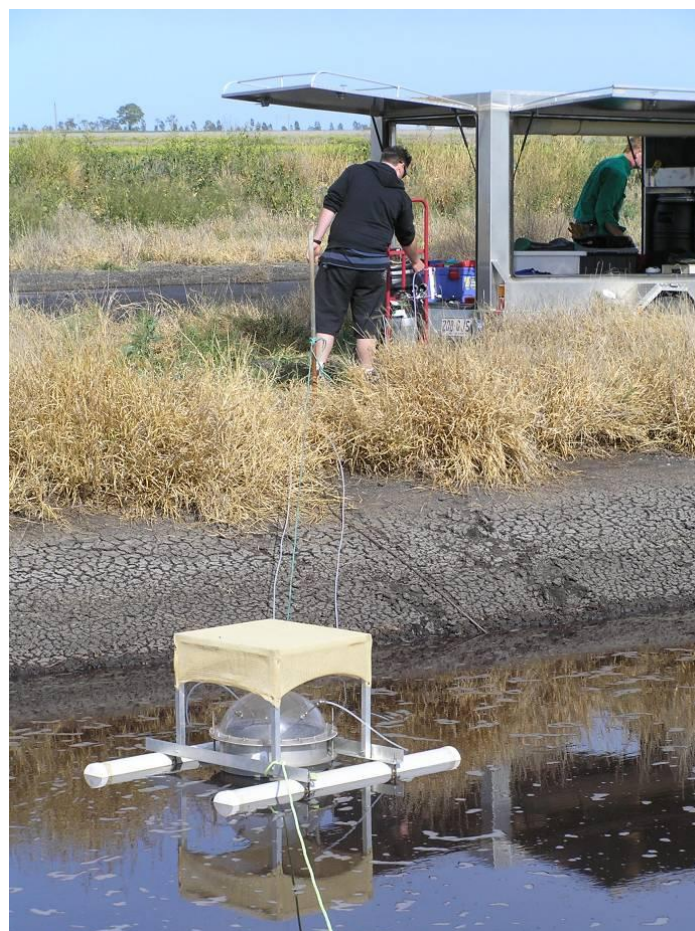
Figure 23: Flux chamber sampling from the drying SEP 2 on 29 August 2012.

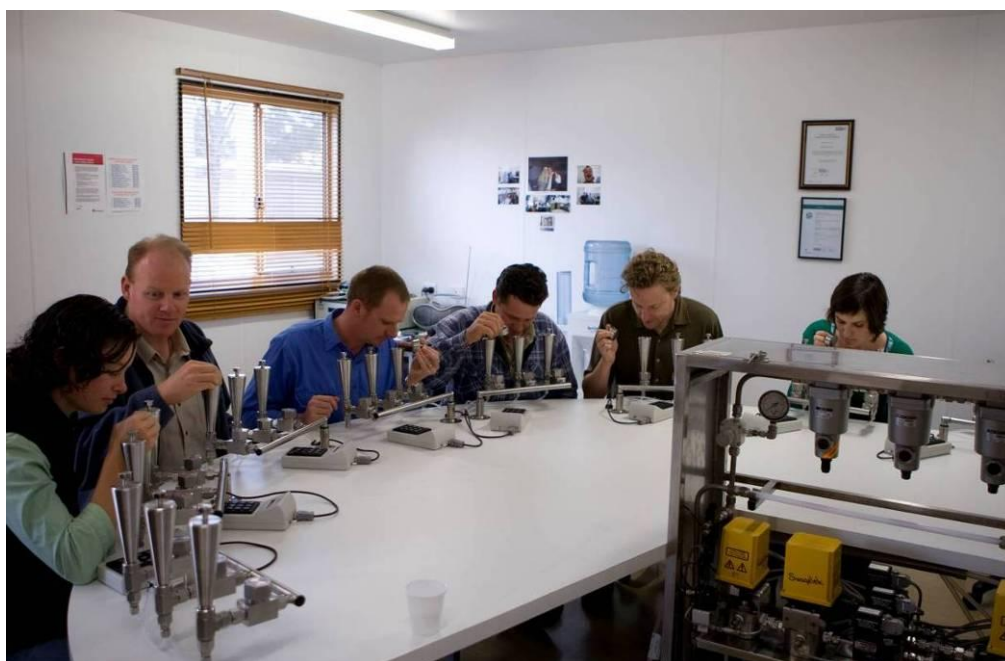
Figure 24: The Agri-Science Queensland olfactometer in operation showing panellists sniffing at ports.

Following delivery of the sampling drums from the SEPS site, odour concentrations were determined using an eight panellist, triangular, forced-choice dynamic olfactometer developed by Agri-Science Queensland (formerly Department of Primary Industries and Fisheries (DPI&F)), as shown in Figure 24. This olfactometer was constructed to meet the requirements of the Australian/New Zealand Standard for Dynamic Olfactometry (AS4323.3). The development of the olfactometer has been described previously.

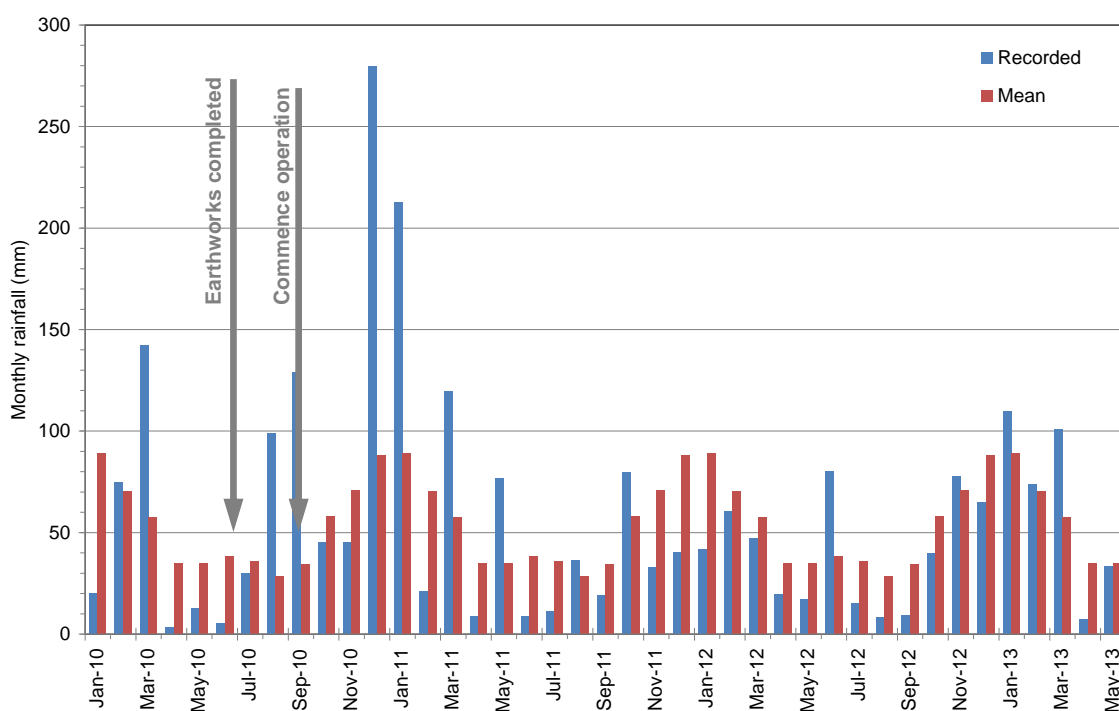
Figure 25: Monthly and average monthly rainfalls recorded at the Jondaryan Post Office (Bureau of Meteorology Station No 41053) over the trial period.

The average monthly rainfalls recorded at the Jondaryan Post Office (Bureau of Meteorology Station No 41053) are provided in Figure 25, along with the actual recorded values over the trial period. This rainfall recording station, which is situated 16.6 km south-east of the piggery site, has more comprehensive rainfall records than the closer Bowenville station.

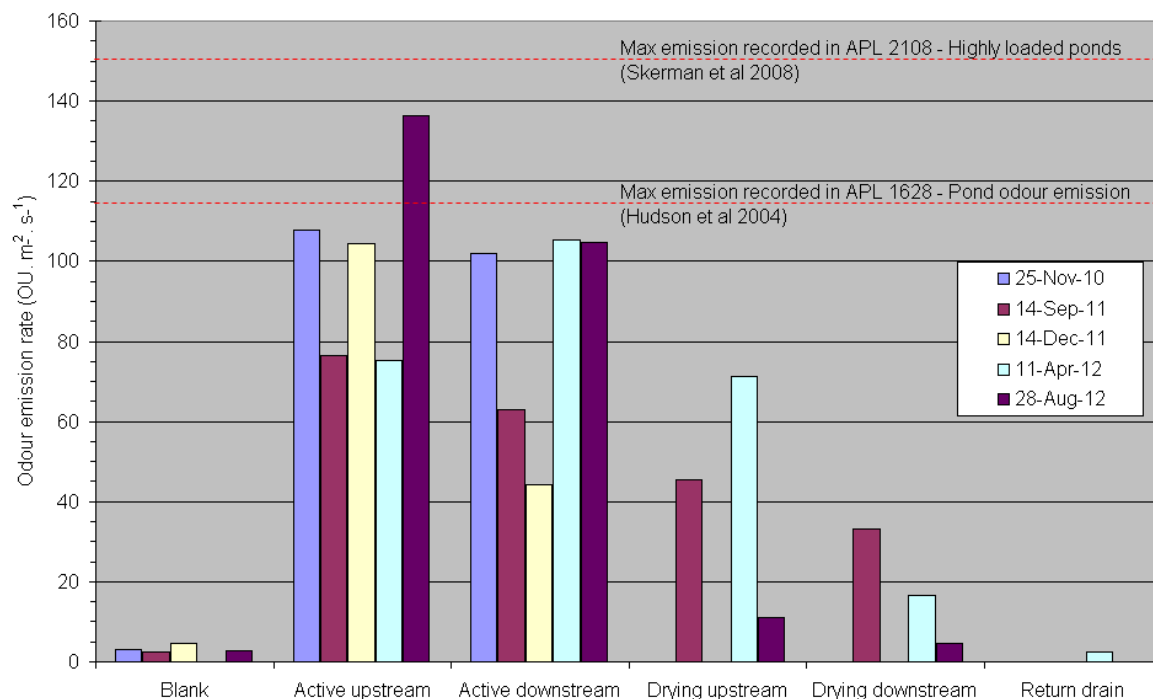
Figure 26: Odour emission rates for samples collected using the wind tunnel, arranged by various areas of the SEPS.

The data, summarised in Table 4 and in Figure 26 and Figure 27, suggests that odour emission rates were generally highest near the inlet (upstream) end of the active SEPS. Based on the wind tunnel data, the average emission rate near the inlet end of the SEPS ($100 \text{ ou.m}^3.\text{m}^{-2}.\text{s}^{-1}$) was approximately 20% higher than near the outlet end ($84 \text{ ou.m}^3.\text{m}^{-2}.\text{s}^{-1}$). The odour emission rates from the drying SEPS were generally lower than for the active SEPS, while the odour emission rates from the return drain were barely detectable using olfactometry.

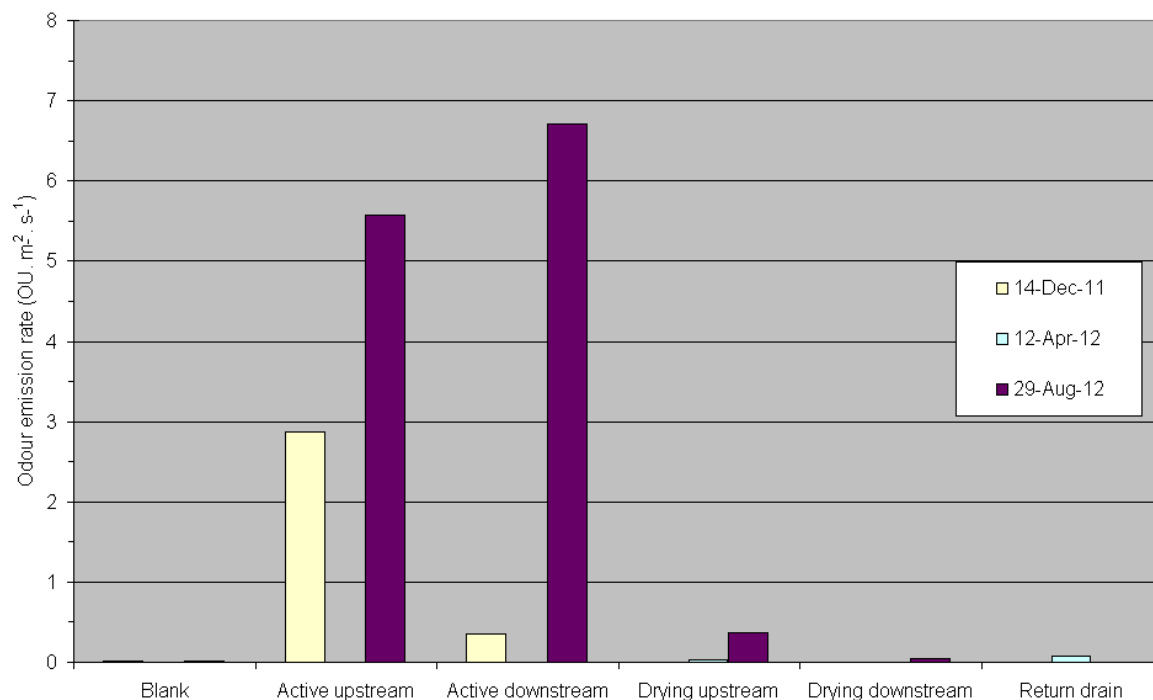
Figure 27: Odour emission rates for samples collected using the flux chamber, arranged by various areas of the SEPS.
