Queensland Sedimentation and Evaporation Pond System (SEPS) Trial

Final Report
APL Project 2009/2248

June 2013

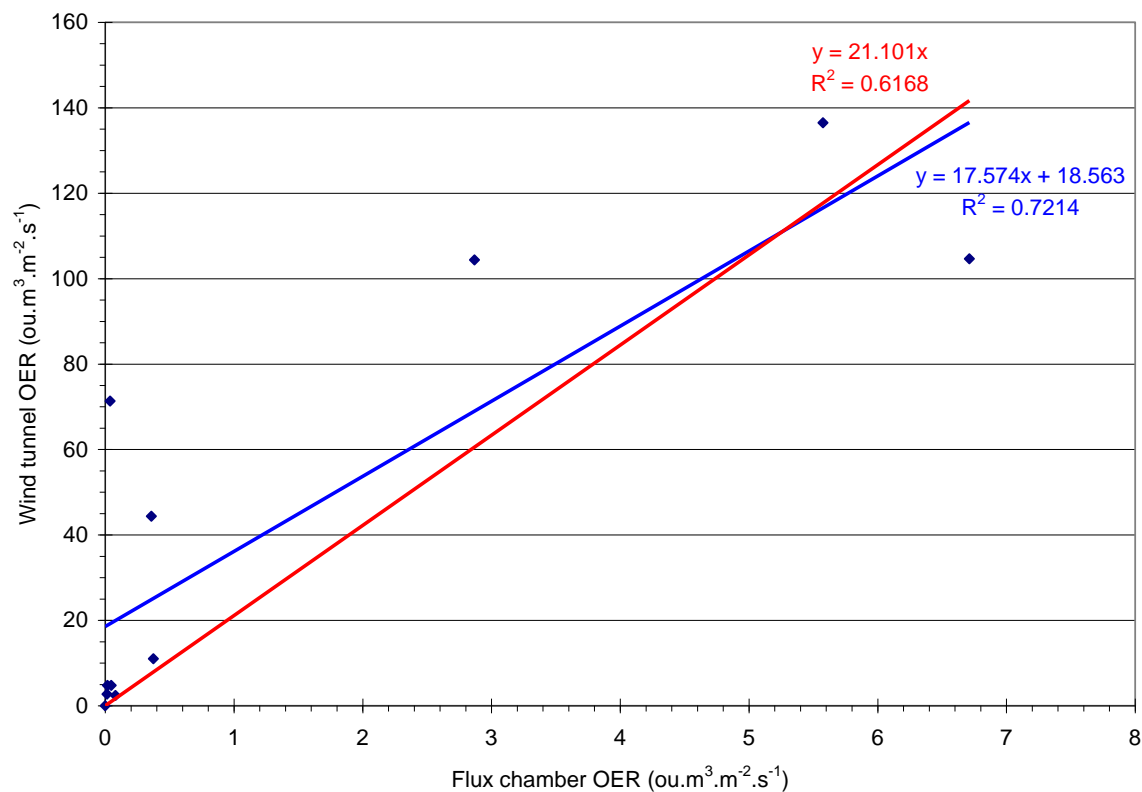
Figure 28: Relationship between odour emission rates determined using the wind tunnel and flux chamber sampling methods.

Figure 28 shows the relationship between odour emission rates determined using the wind tunnel and flux chamber sampling methods. From this graph, it is clear that there is a relatively poor correlation between the odour emission rates determined for samples collected using these two methods. In general, the wind tunnel odour emission rates are approximately 20 times the flux chamber values. This is consistent with the findings of previous researchers [Hayes *et al.* (2008), Kaye and Jiang (1999) and Hudson (1995)].

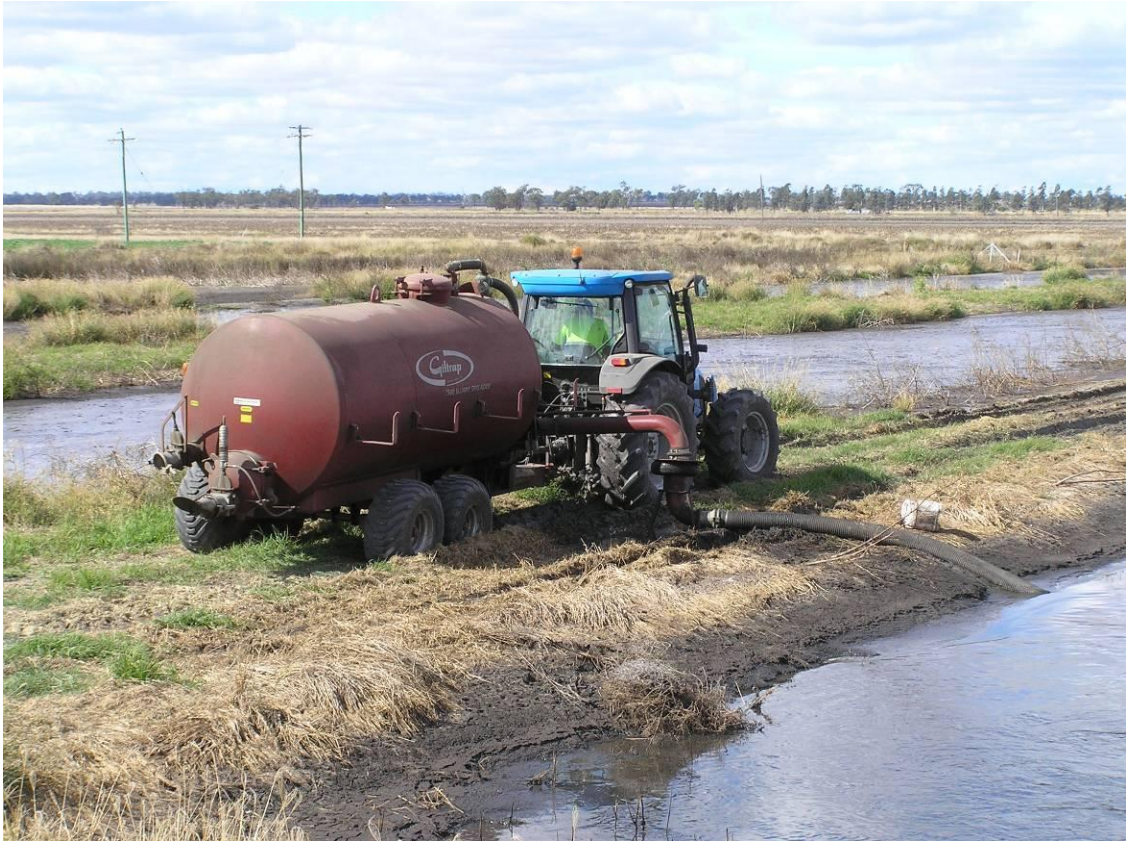
Figure 29: Giltrap slurry spreader lifting agitated slurry from SEP 3.

Photographs of the vacuum tanker and agitator in operation at the SEPS site on 7 June 2013 are provided in Figures 29 to 32.

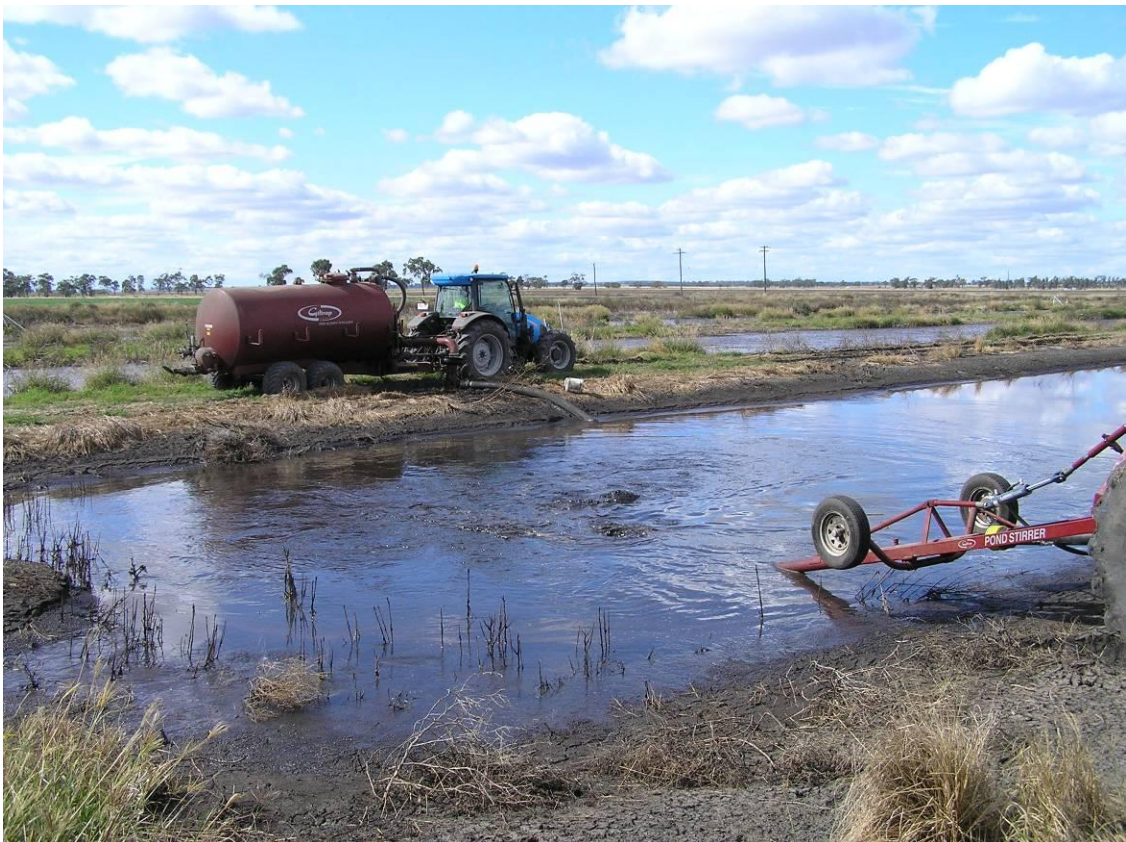
Figure 30: Giltrap slurry spreader and pond stirrer operating on SEP 3.

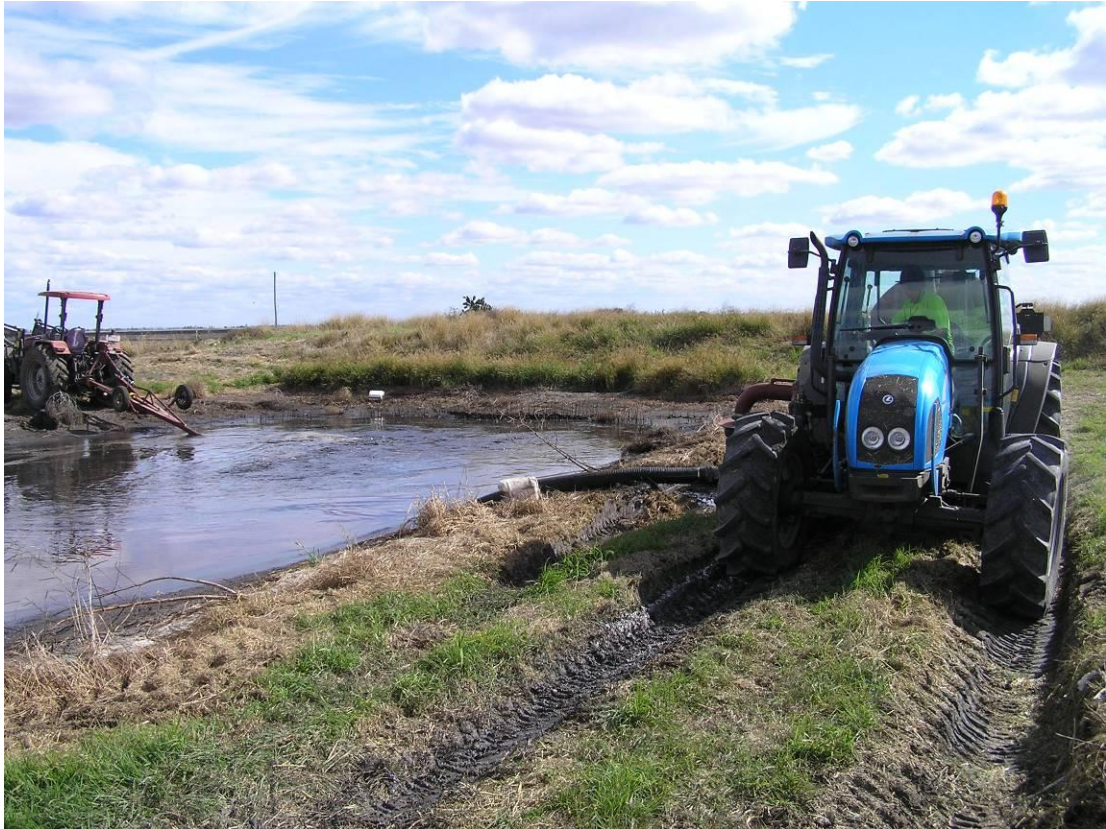
Figure 31: Giltrap slurry spreader and pond stirrer operating near the upstream end of SEP 3.

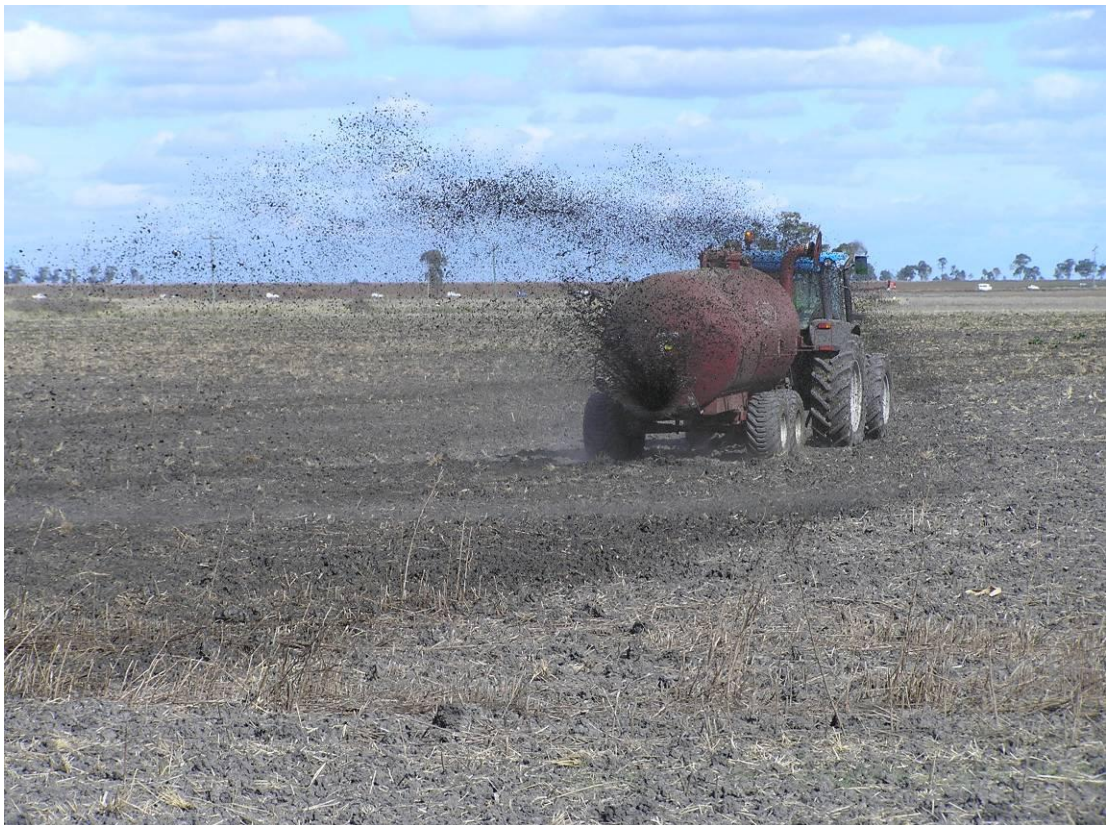
Figure 32: Giltrap slurry spreader applying slurry to nearby cultivation paddock.

The vacuum tanker spread the slurry onto a cultivated paddock located directly south from the SEPS. It is anticipated that a wheat crop for hay production will be planted in this paddock in the near future. Very little odour was observed throughout the solids removal and application process. It is understood that most of the accumulated solids were successfully removed from SEP 3 and approximately half the solids were removed from SEP 1 over a period of approximately 4 days. The contractor had not advised the number of tanker loads applied to the cultivation at the time that this report was completed. The piggery manager is expecting to receive this report from the contractor in the near future.

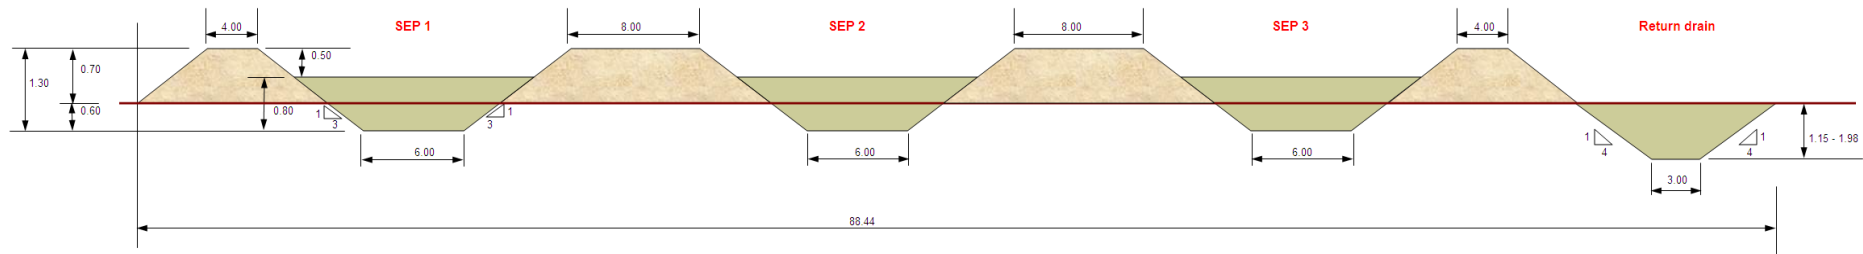
Figure 2: Sectional elevation through SEPS on 'AA'.
